BROWNSVILLE ROAD CORRIDOR

TRAFFIC SAFETY PLAN

Calhoun Ave to Maytide St.

Focus Group Meeting Date-05/23/2023

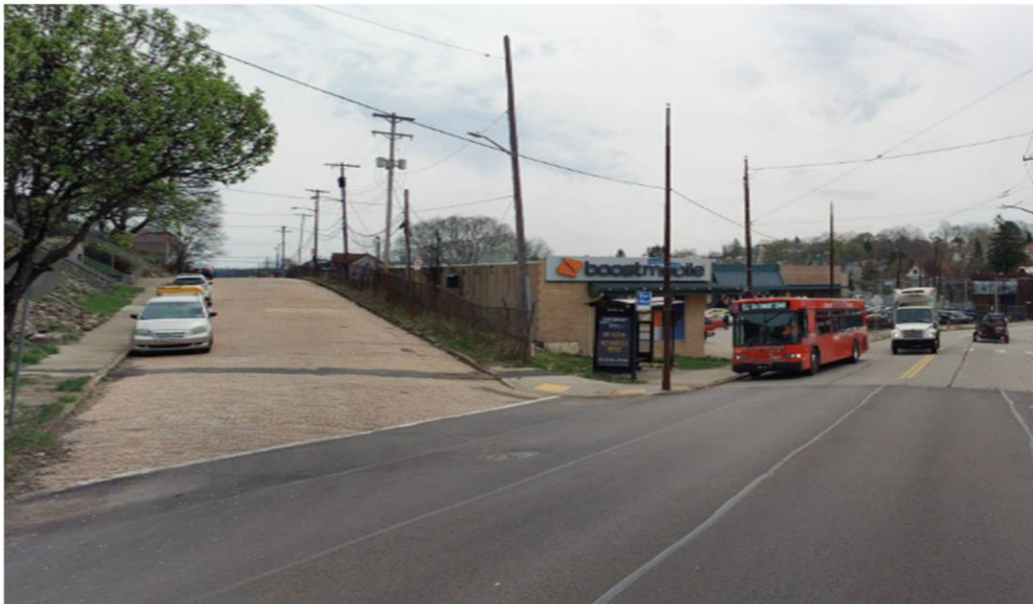
Wynoka St & Brownsville Rd “Y” Intersection

- High pedestrian generator segment.
 - High volume driveways.
 - Un-signalized pedestrian crossing location
 - Lighting improvements needed
- Wynoka St should be realigned from a “Y” to a “T” intersection.

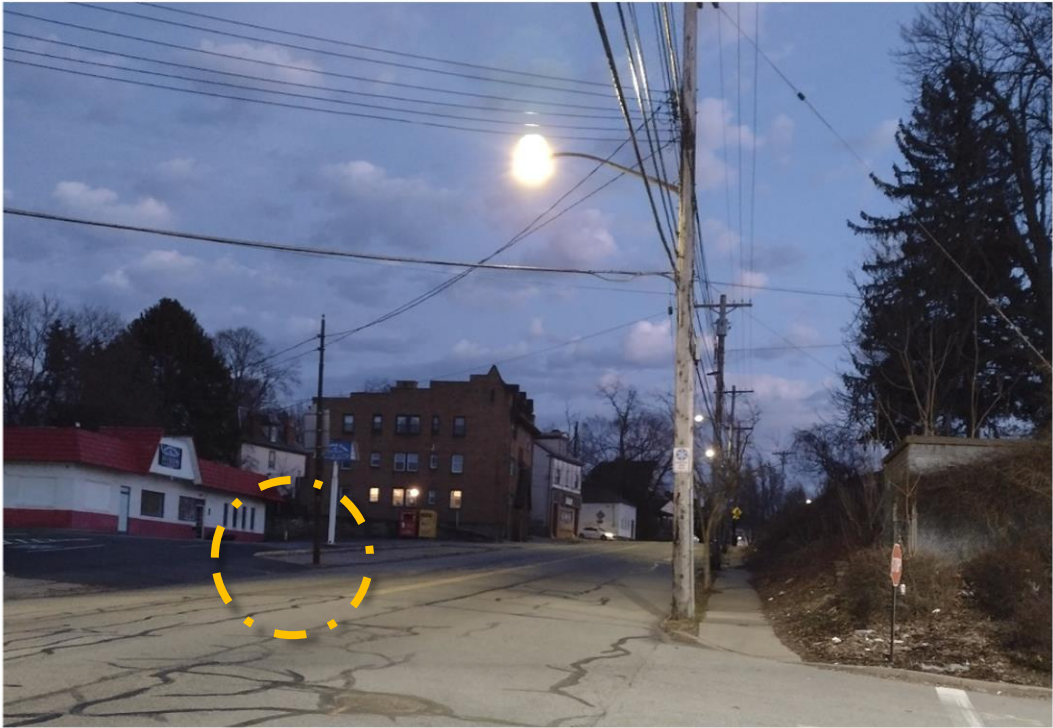
Birmingham Ave & Brownsville Rd

- Un-signalized pedestrian crossing needs improvement
- Lighting improvements needed

One side street lighting which is present along the corridor creates dark spots along intersections and driveways (seen above).

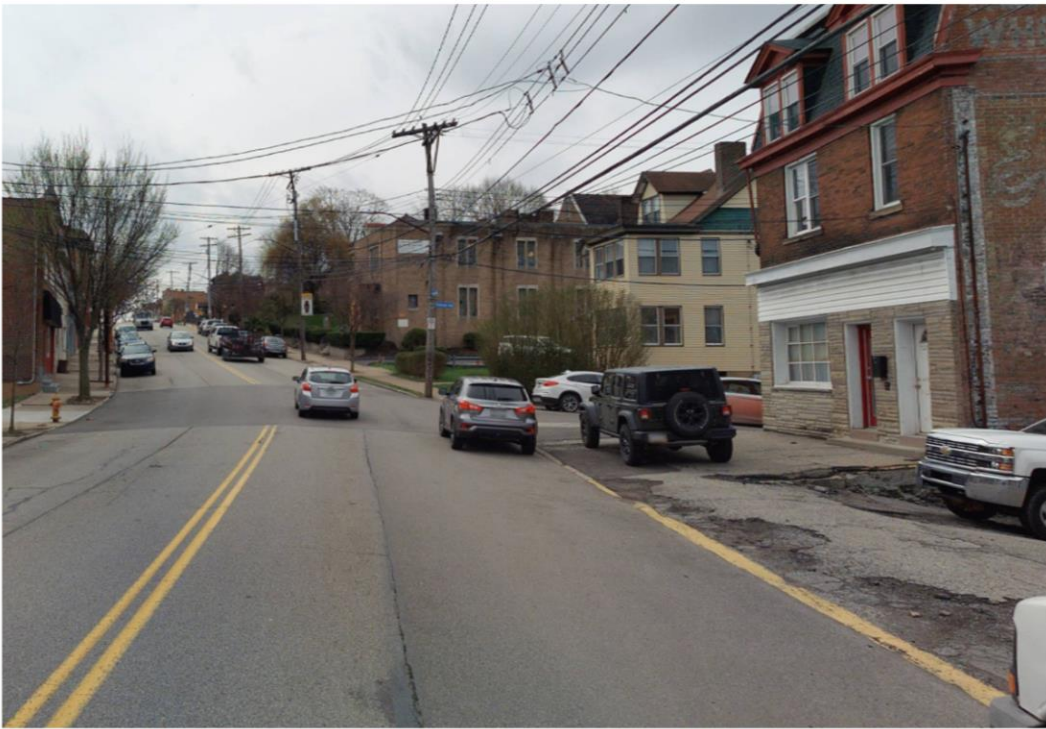
Thielman Ave & Brownsville Rd

- Deteriorated sidewalk and curb ramps
- Lighting upgrade needed
- Sightline improvement needed

Deteriorated sidewalks create an inaccessible pedestrian environment. This is the result of improper sidewalk material (Asphalt) as well as unpermitted curb cuts/parking.

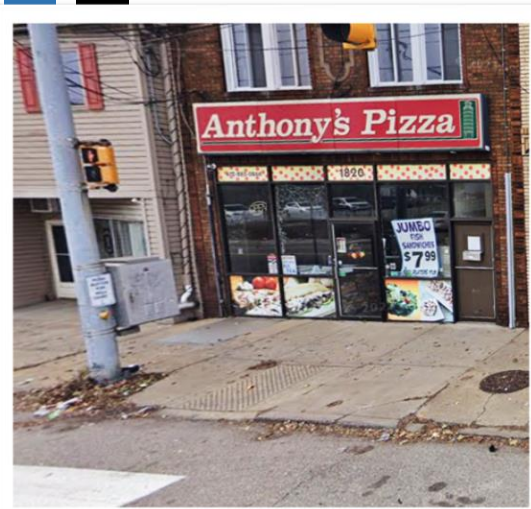
Outdated ADA Curb Ramps at Crailo and Newitt (both)

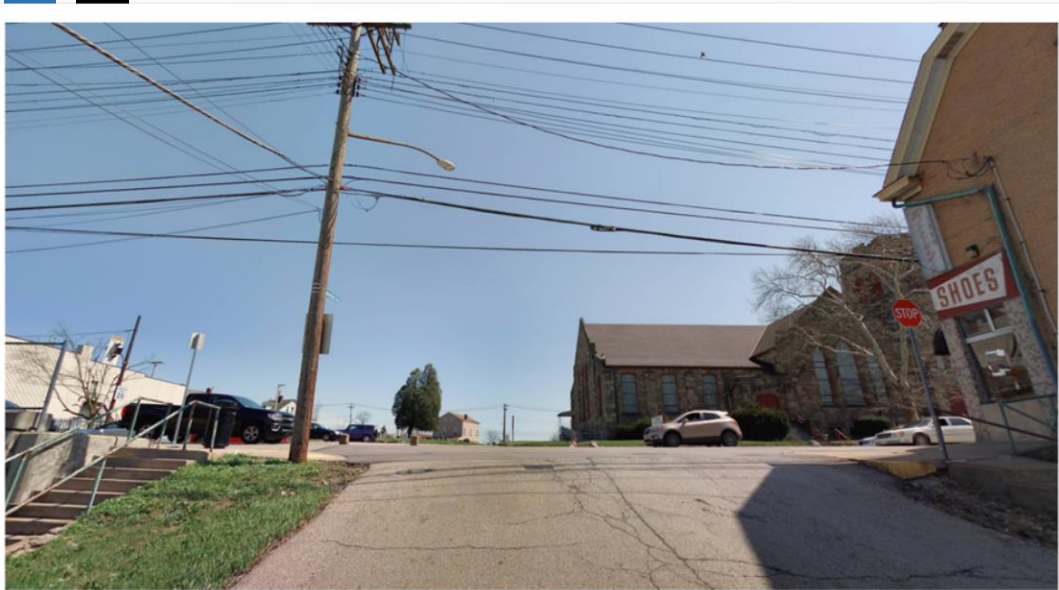
Copperfield Ave & Brownsville Rd

- Encourage use of nearby signalized crossing at Crailo Ave
- Sightline improvements needed for vehicles turning from Copperfield

Sightline is severely restricted turning from Copperfield to Brownsville due to the grade off Copperfield Ave.

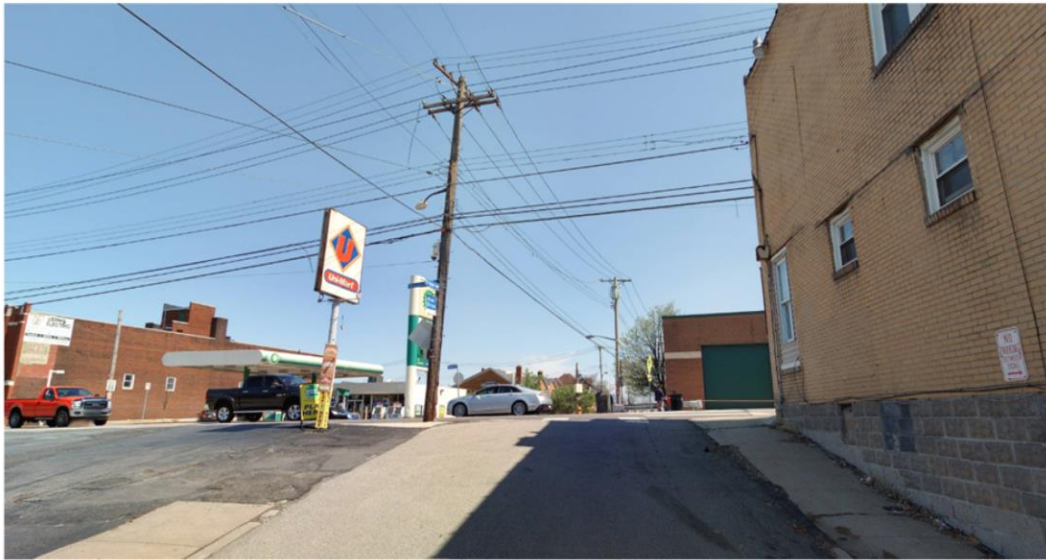
Agnew Ave & Brownsville Rd

- Un-signalized pedestrian crossing needs improvement
- Sidewalk upgrades needed
- Sightline improvement needed on W. Agnew Ave.
- Access management for customers to BP and Uni-Mart

Visibility is limited for vehicles approaching Brownsville Rd. from W. Agnew Ave. This section of the corridor sees high vehicular and pedestrian volumes due to popular destinations (BP & Uni-Mart).

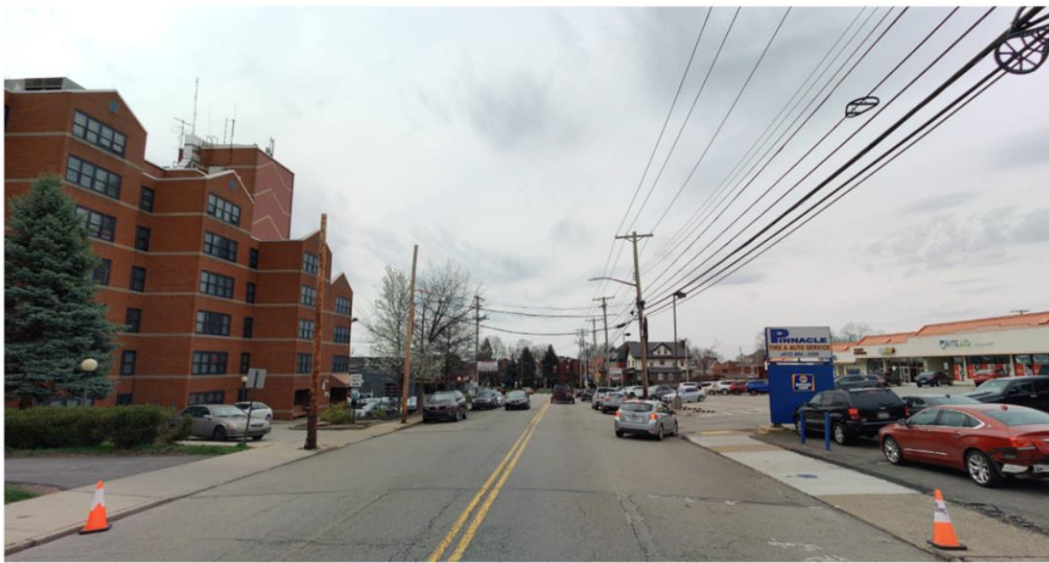
Woodford Ave & Brownsville Rd

- Woodford Ave: Un signalized pedestrian crossing needs improvement
- Access management needed for busy shopping destinations and apartment building in this section.

- On-street parking management needed to ensure clear sightline for driveway in/out.
- **Distracted driving related crash.**

This section of the corridor is a busy residential and commercial area with multiple driveways on each side of Brownsville Rd.

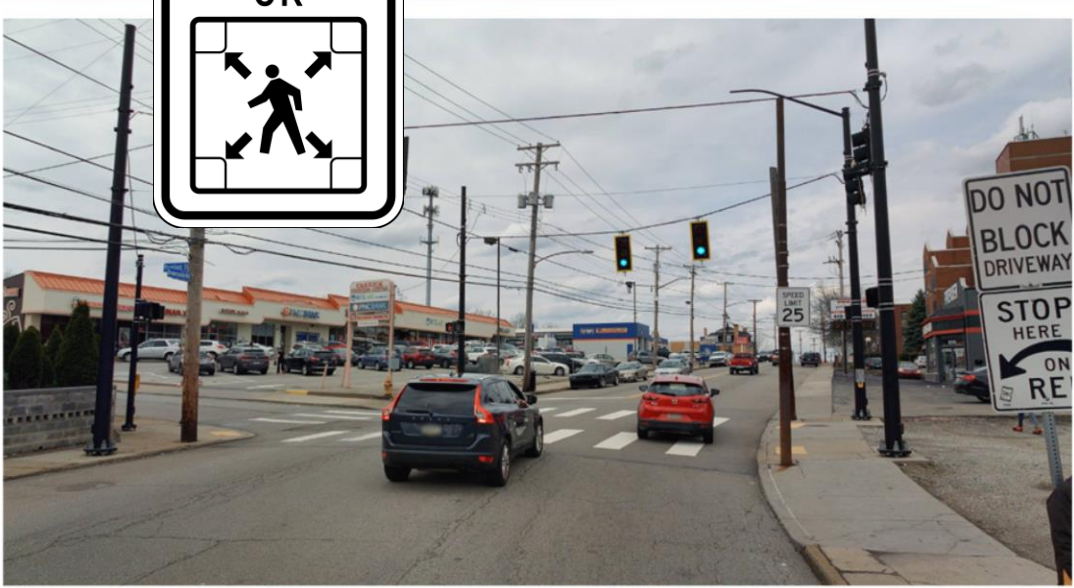
Parkfield St & Brownsville Rd

- High pedestrian generators: Carrick High School, shops and apts.
- Speeding issue around the curve.
- New signal in place with scramble phase. Signage needs to be added to indicate diagonal crossing .

This section of the corridor is a busy residential and commercial area with multiple driveways on each side of Brownsville Rd.

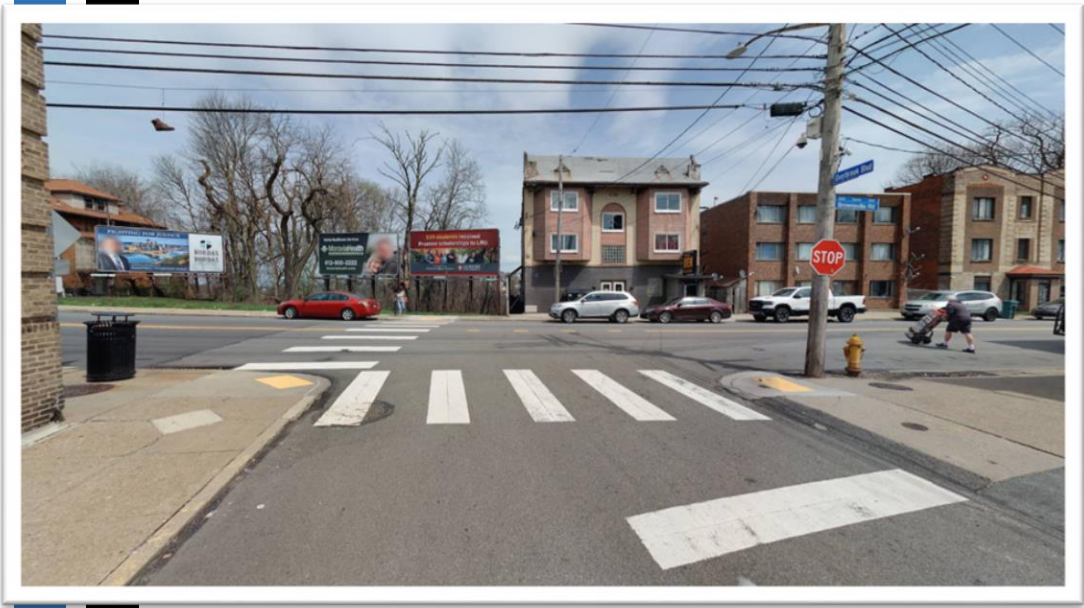
Overbrook Blvd & Brownsville Rd

- Un signalized pedestrian crossing needs improvement
- Sidewalk upgrades needed
- Evaluate left turn lane necessity
- Discourage parking near crosswalk.

Vehicles turning on to Brownsville Rd from Overbrook have limited sightline due to adjacent buildings.

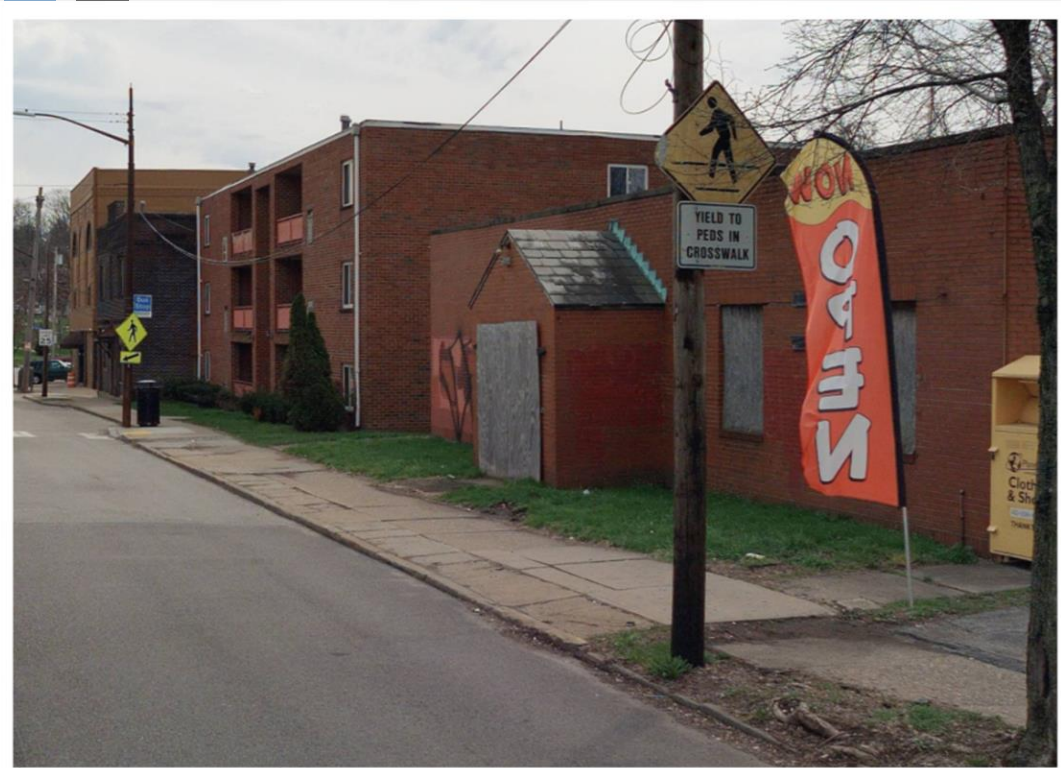
Clifton Blvd & Brownsville Rd

- Un-signalized pedestrian crossing location
- Lighting upgrades needed
- Sidewalk upgrades needed

Sidewalk on the south side of Brownsville Rd approaching Clifton Blvd is deteriorated and needs improvements.

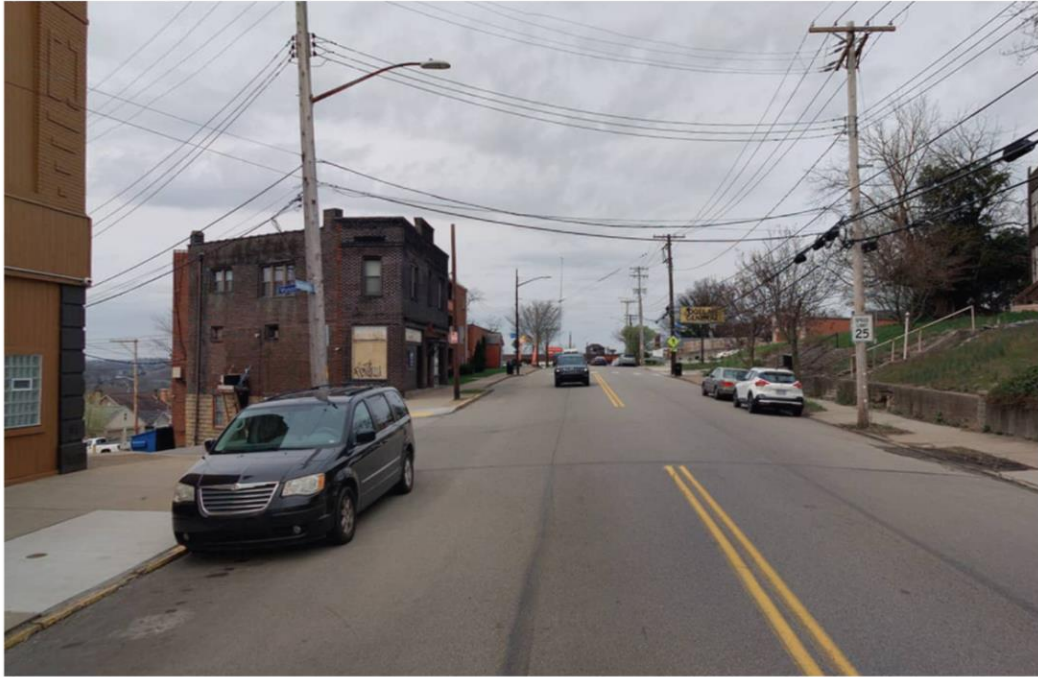
Wycox St & Brownsville Rd

- Speeding concerns.
- Sightline improvement needed.

Wycox and Brownsville is not an appropriate intersection for pedestrian crossings. Pedestrians should be encouraged to cross at Clifton.

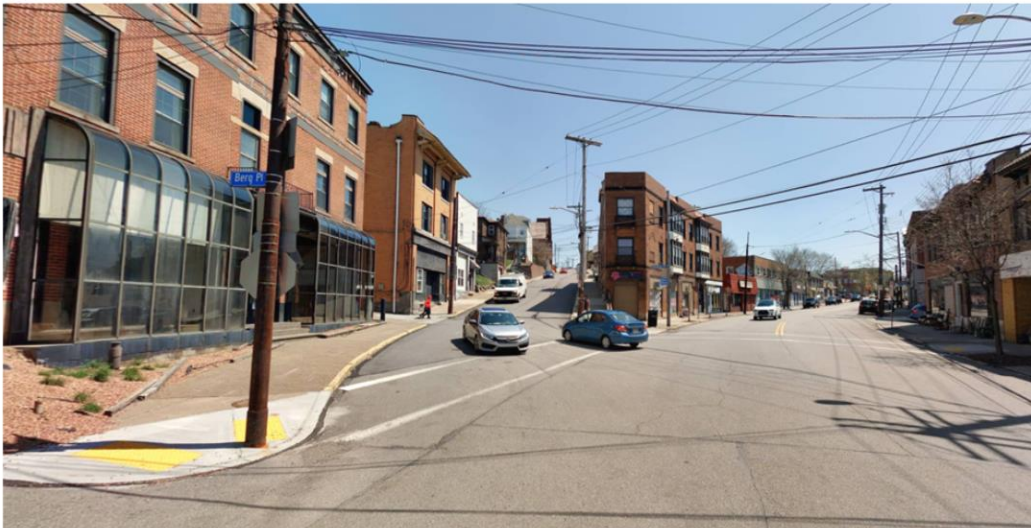
Churchview Ave & Brownsville Rd

- Sightline issues. Intersection should be realigned from “Y” to “T”
- Un signalized pedestrian crossing improvements needed.
- Crosswalk upgrades needed.
- Lighting upgrades needed.

- Sightline issues at Gas station due to parking
- Sidewalk upgrades needed
- Lighting upgrades needed
- Lane delineation improvements needed

The “Y” intersection creates sightline issues for vehicles turning on to Brownsville Rd.

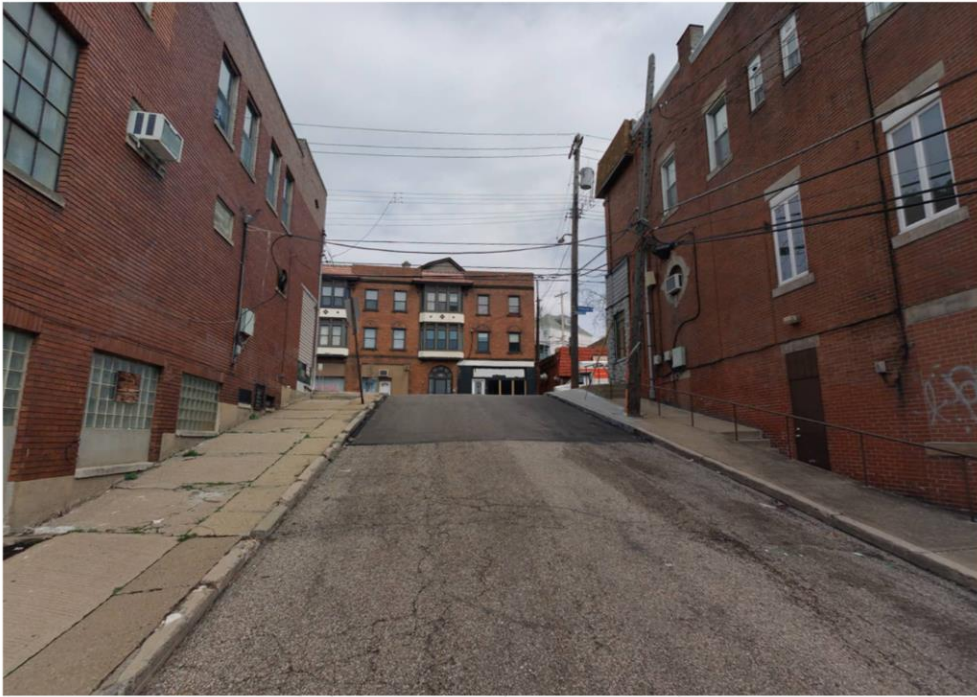
Belplain St & Brownsville Rd

- Sightline issues due to grade .
- Sidewalk upgrades needed
- Crossing should be discouraged at this intersection and directed to Chruchview Ave.

The grade of Belplain St creates a sightline issue for vehicles approaching Brownsville Rd.
