# Mt. Washington Landslide Mitigation

Reese Street & Greenleaf Street Project: Public Information Meeting #1  
March 23, 2022

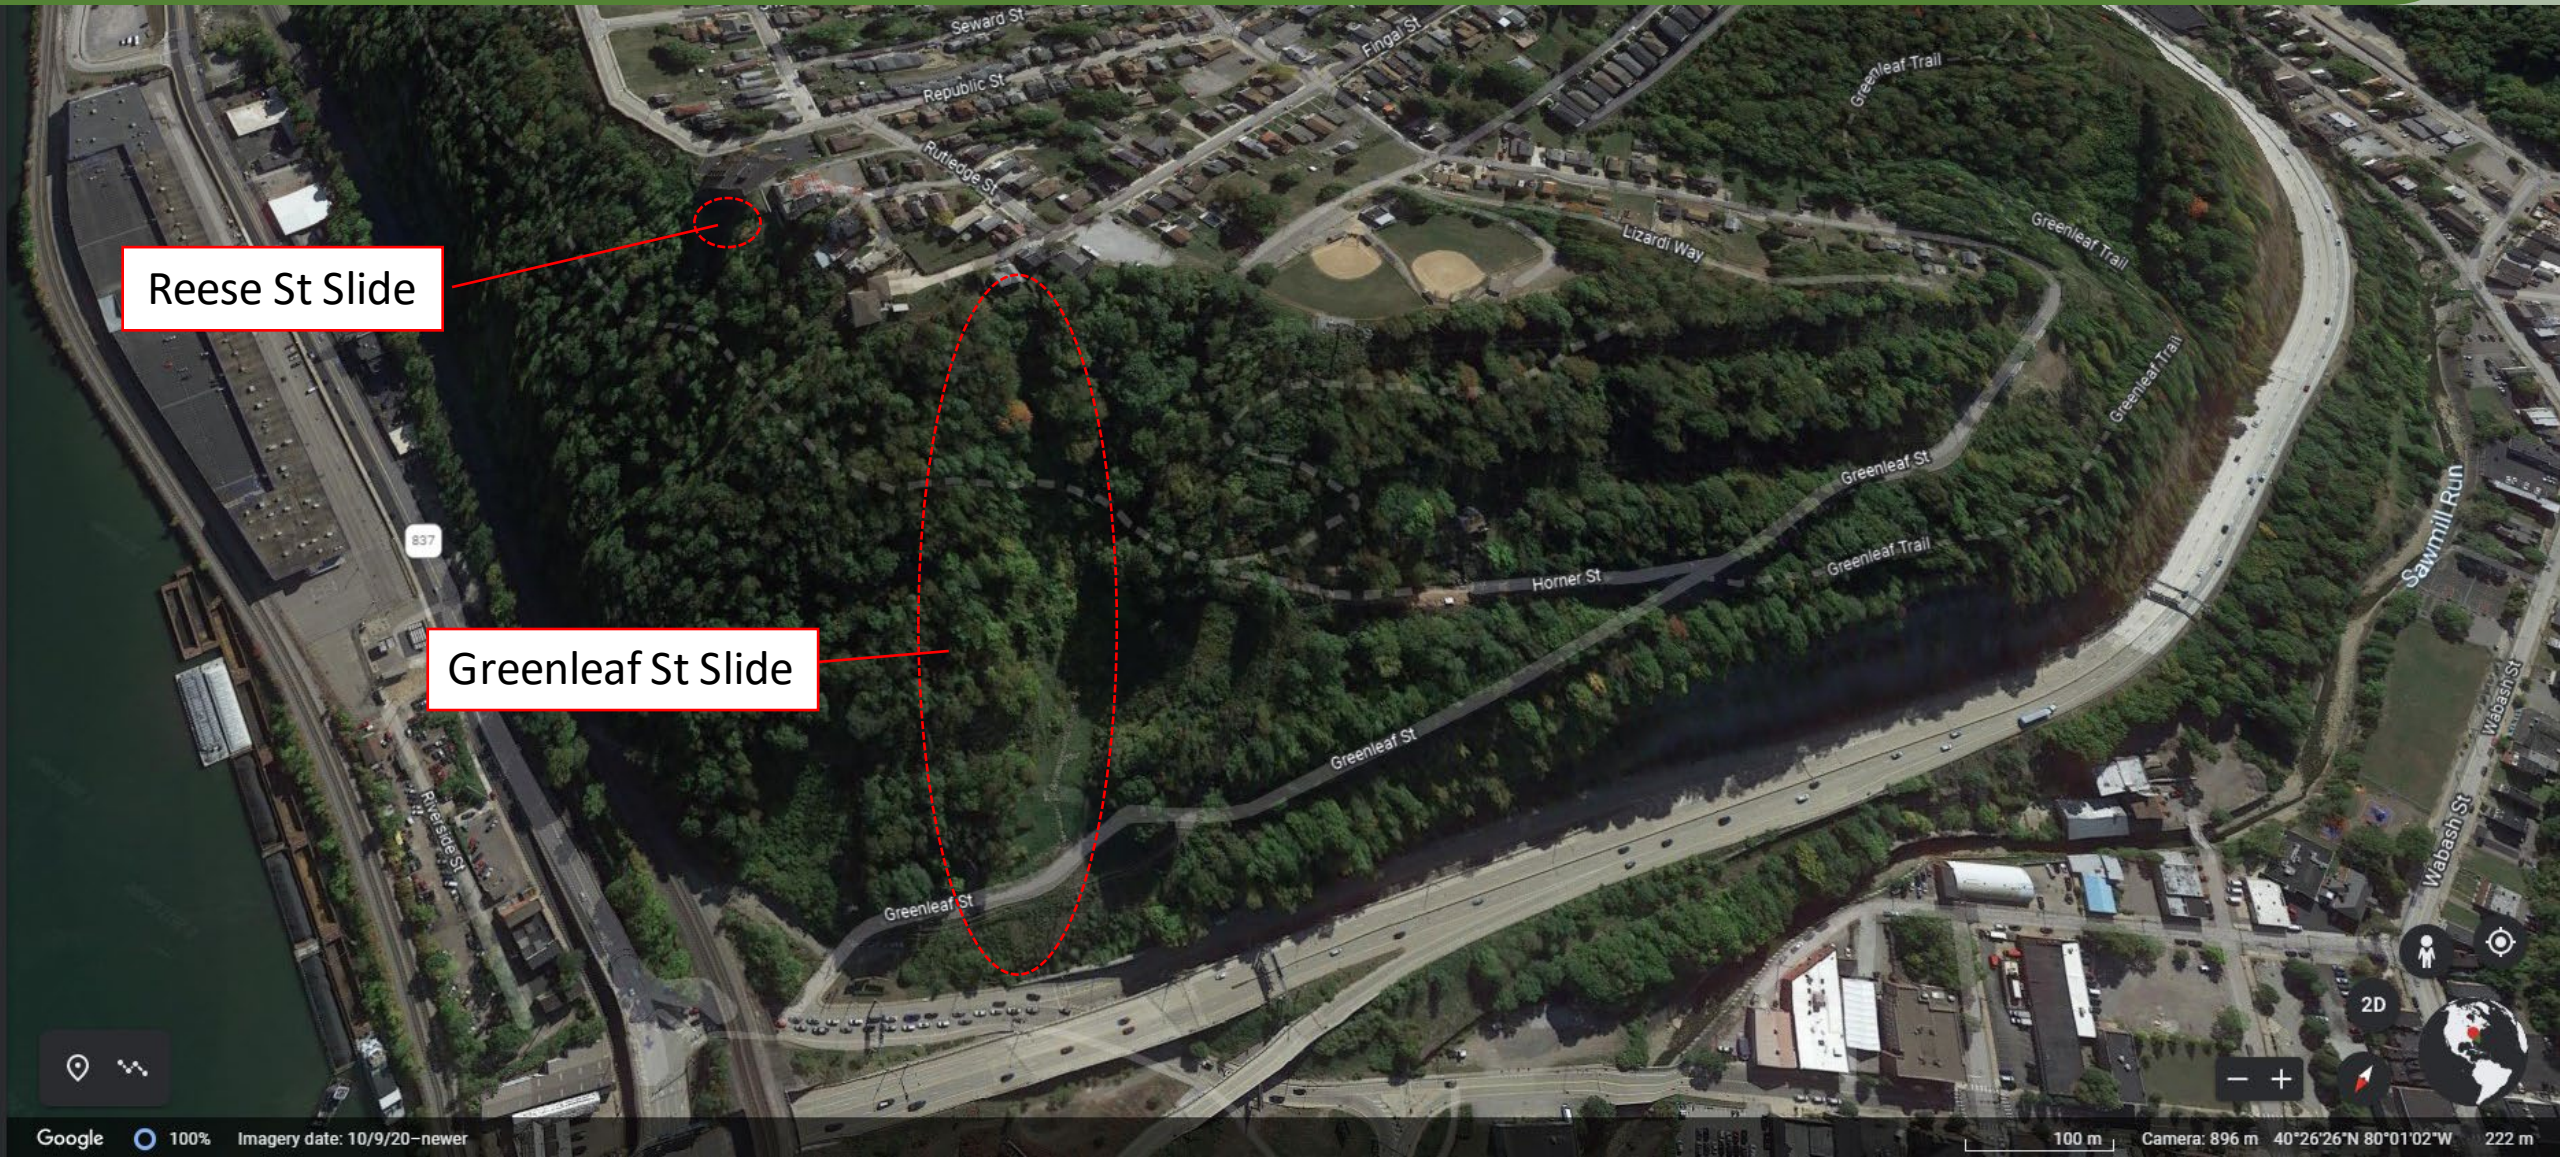
# Greenleaf / Reese Street

Reese St Slide

Greenleaf St Slide

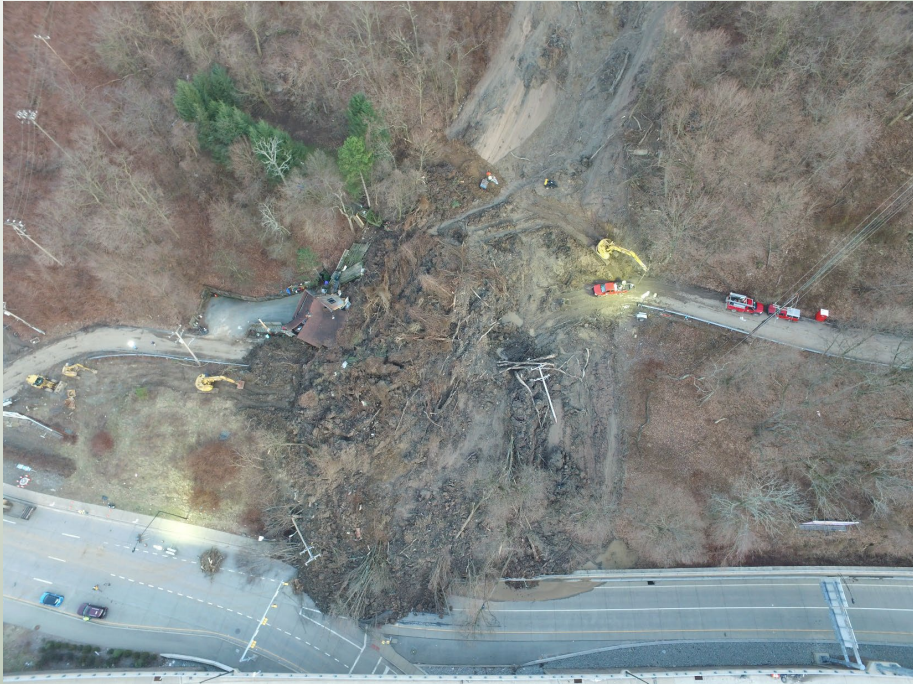
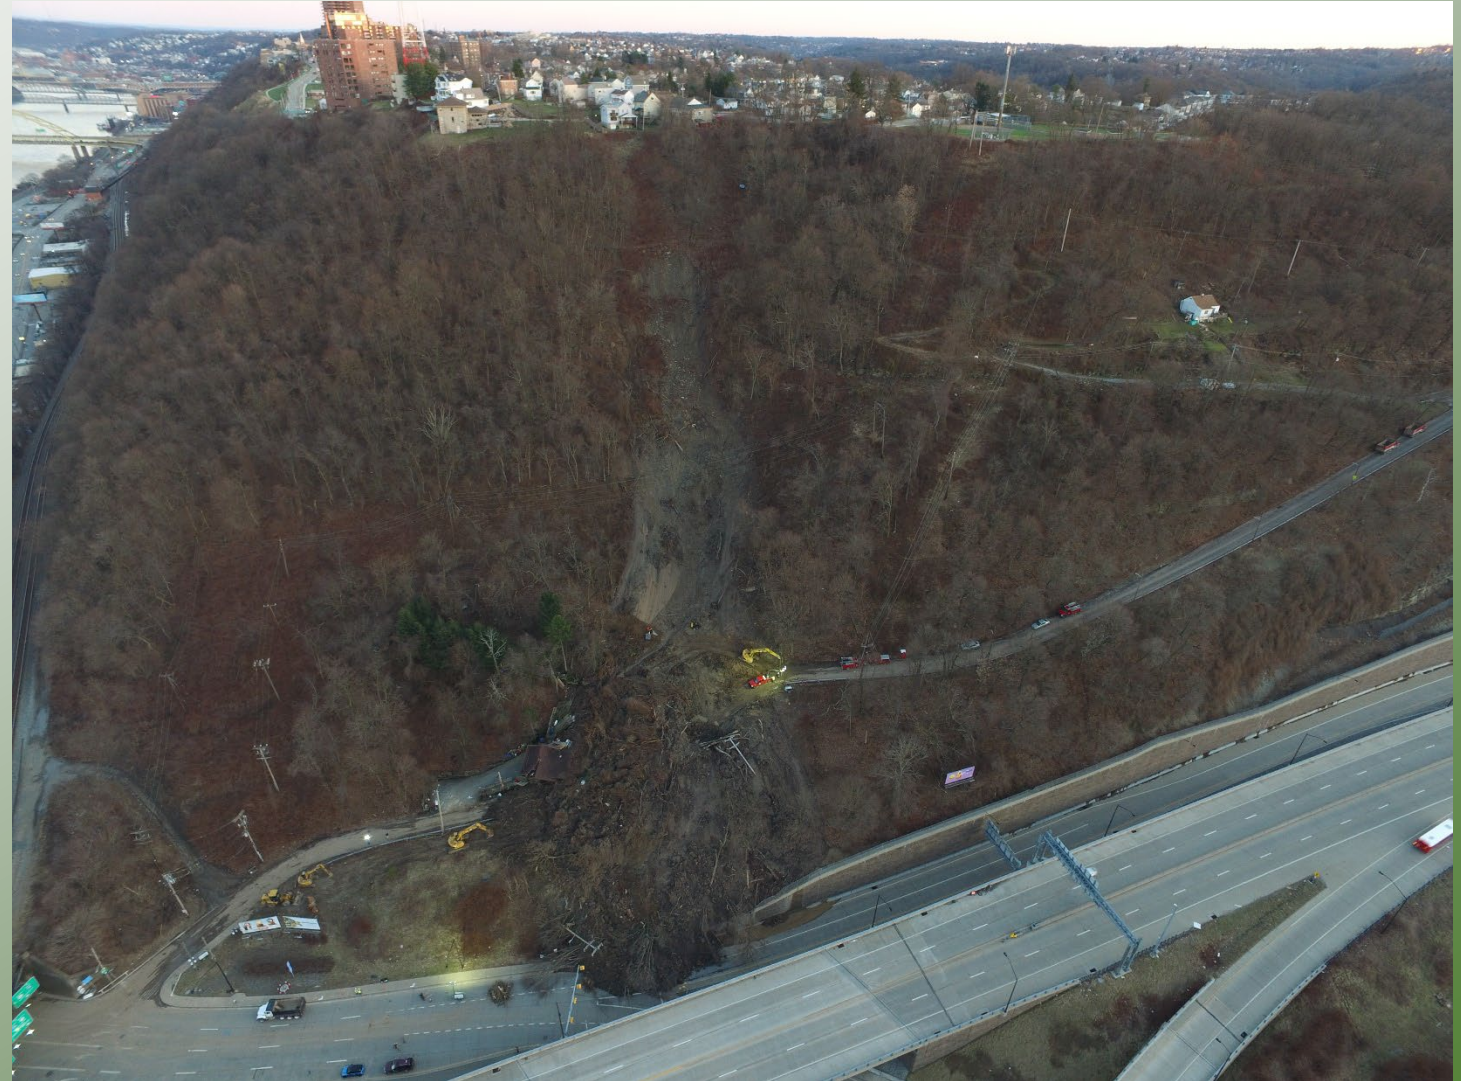
# Greenleaf Street

2018 - Catastrophic failure

- Destroys home
- Blocks Roadway
- Severs Trail

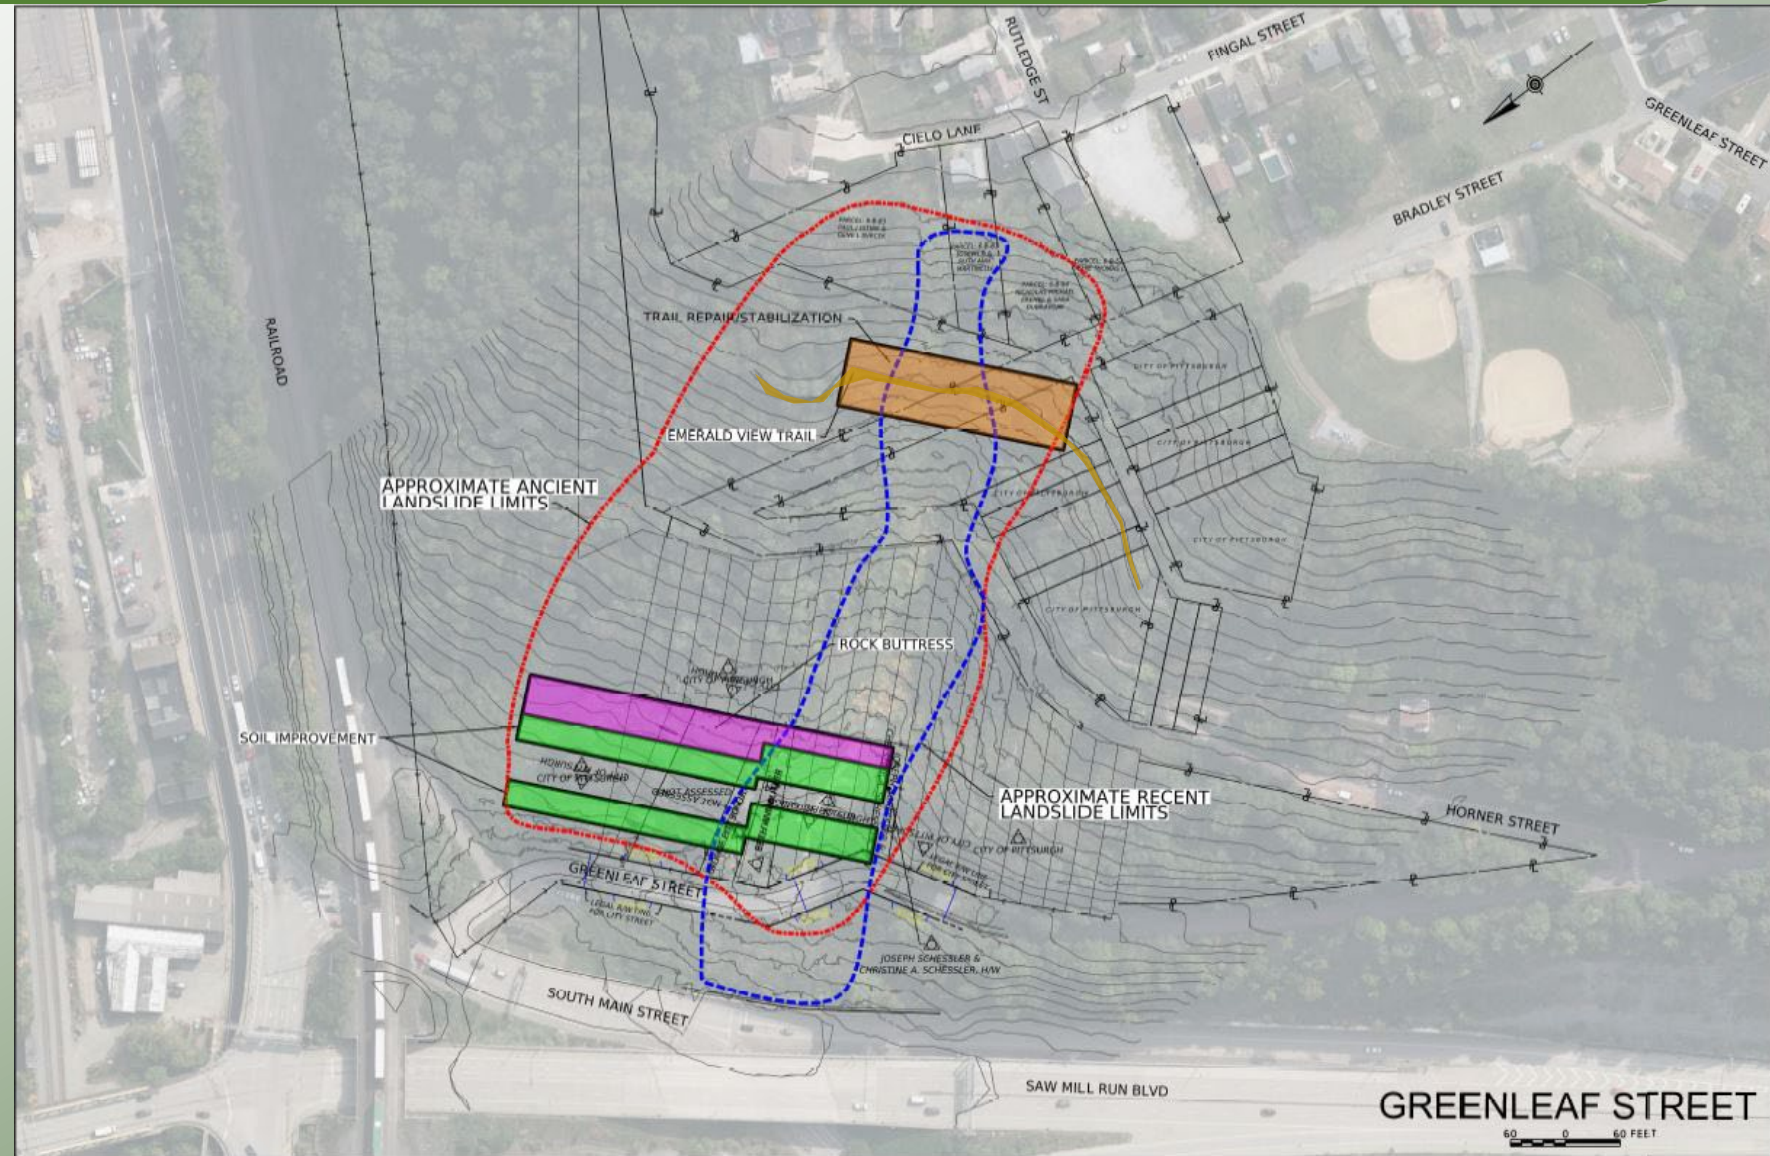
# Mitigation Concepts

Two areas to stabilize:

- Toe of slope
- Trail
