CITY OF PITTSBURGH
**THREE RIVERS HERITAGE TRAIL
MAINTENANCE & MANAGEMENT PLAN**

MARCH 2026

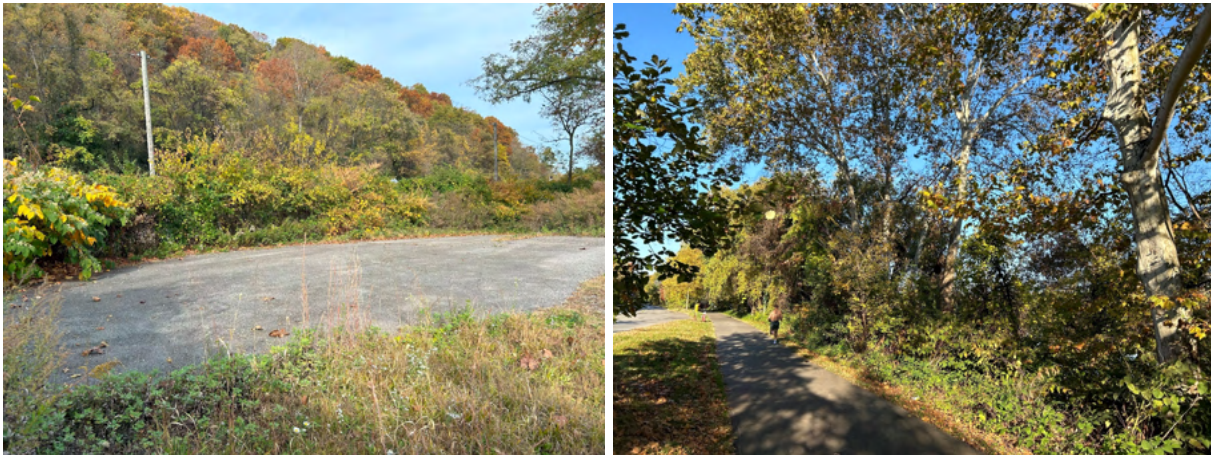
Examples of low (left; Duck Hollow Trail) and moderate (right; Allegheny River Trail) canopy density. There were no areas identified as having high canopy density.

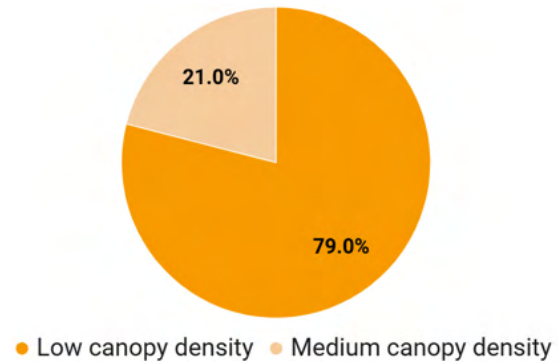
Chart: Tree Canopy density

Across the entire trail system, 79% of field-identified trail segments had low canopy density (extensive areas with no or sparse tree cover) and 21% had medium canopy density (scattered openings or continuous tree cover with open canopy). While no field-identified segments had high canopy density (continuous tree cover with closed canopy), smaller areas within segments occasionally did have relatively high density, especially between Hazelwood and Duck Hollow on the north shore of the Monongahela River. Some areas of low or medium canopy have limited opportunity to establish such canopy due to surrounding infrastructure, including most of the Eliza Furnace Trail and between the Carnegie Science Center and PNC Park. Analysis of aerial imagery will further refine estimates and locations of openings and other opportunities for tree planting.

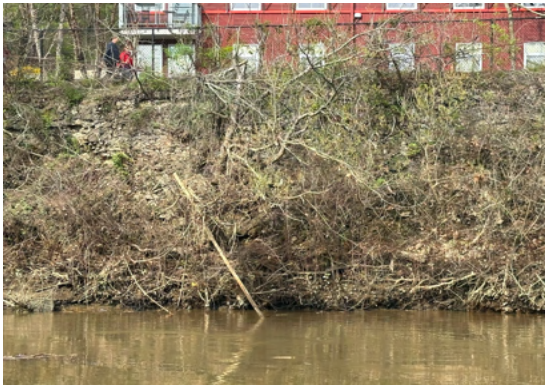
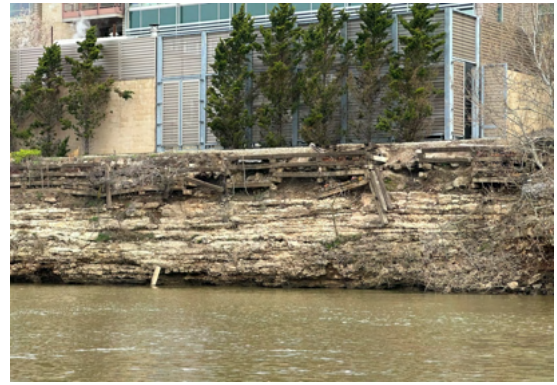
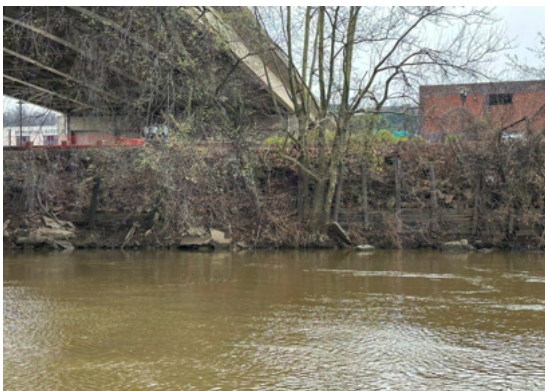
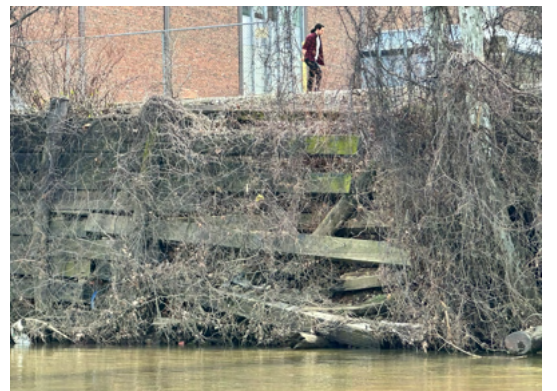
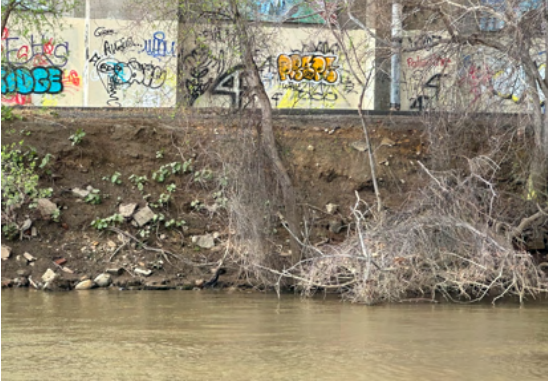
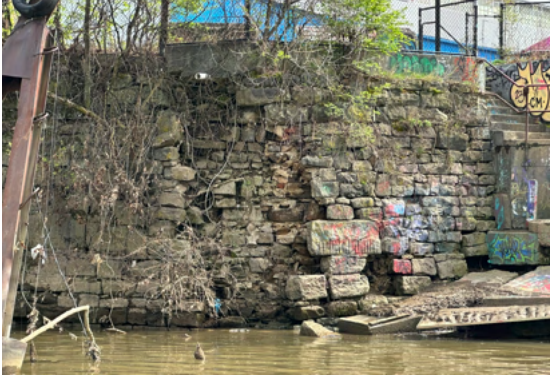
Additional assessment of retaining walls, engineered river walls, stabilized and naturalized slopes was conducted during a related boat trip, and includes walls that are not necessarily visible from the trail, but would potentially impact the trail should they fail. Because the areas were not easily accessed, the data collected for these walls and shorelines include georeferenced photos, with direction areas, but not high-accuracy GPS data. As such, the linear wall and shoreline features shown on the assessment web map for this project are derived from the previously-performed Army Corp of Engineers (ACOE) Shoreline Assessment Study, using a 40-foot buffer from the trail centerline to determine which walls and shorelines are most critical to the safety and operations of the Three Rivers Heritage Trail network. The detailed observations, risk assessments, and recommendations provided by the Project Team were derived from direct visual assessment, combined with the original ACOE condition assessments (Poor, Fair, Favorable). More importantly, where direct correlations were observed between walls and shorelines in questionable conditions and actual defects of the trail, these correlations were noted in the trail assessment reporting. Below are some select photos of locations where walls or slopes in questionable condition come in close proximity to the trail edge.

The trail assessment performed as part of this project identified numerous locations where steep, potentially unstable slopes or retaining walls in various states of disrepair are located within close proximity to the Three Rivers Heritage Trail. In some cases, there were indicators in the trail segment—edge and longitudinal cracking, significant traverse cracking, trail surface displacement, etc.—that seemed to directly correlate with failing slopes or walls immediately adjacent. These were identified in the trail scoring as being in ‘poor’ condition with regard to safety risks, and should be treated as high priority for additional evaluation and remediation by the city, if needed.

Unfortunately, some of the failing wall sections are not located on city property, and so the priority should be on engaging and working with the landowners to remediate public safety risks to trail users. Regardless of ownership, the city is encouraged to consider alternatives to in-kind replacement of riverbank retaining walls and hard steep slope revetments. If site conditions permit, more naturalized streambank stabilization and bioengineering solutions may offer ecological, resilience, and lifecycle cost benefits over more conventional solutions.

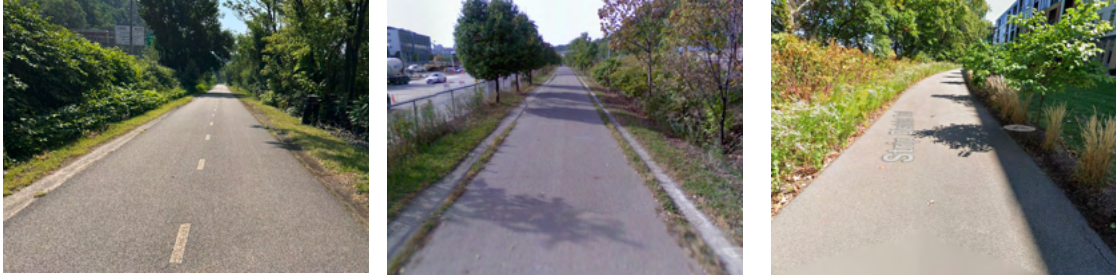
Good: no major faults

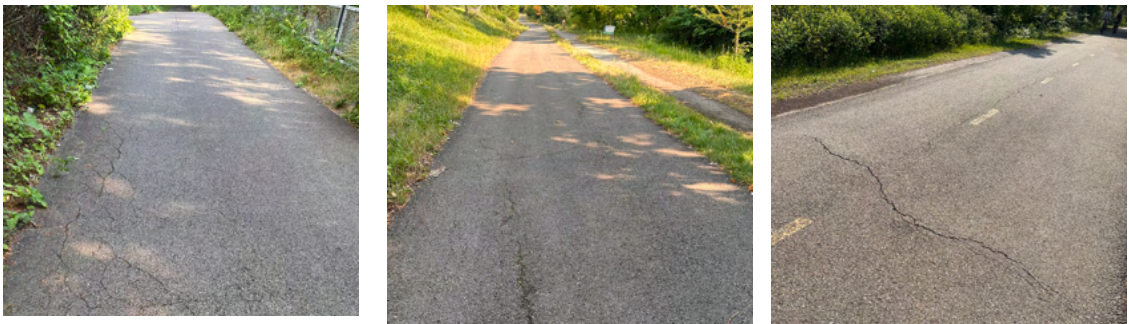
Fair: minor cracks and potholes that have been filled, minor tripping hazards, wayfinding issues

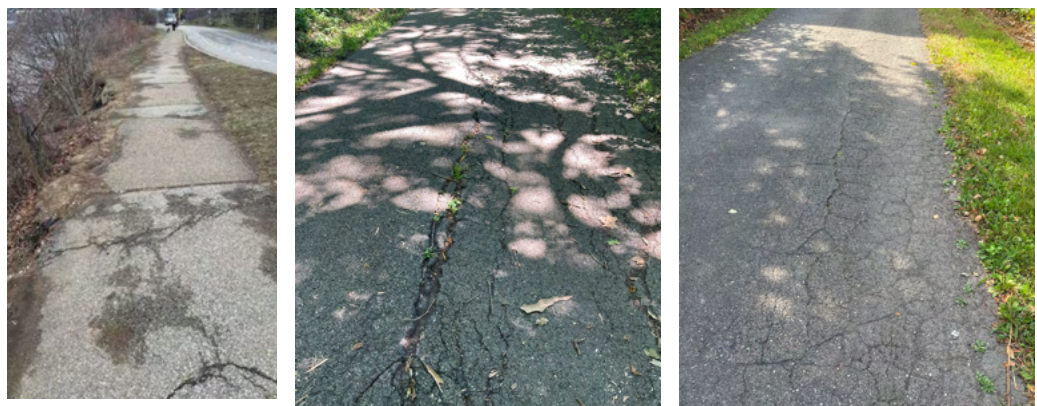
Poor: major cracks, uneven surface, tripping hazards, unfilled potholes, wayfinding issues

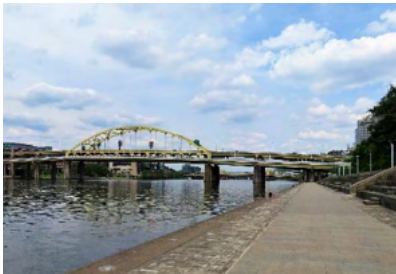
- Celebrated Civic Spaces: such as Allegheny South Section 1 and Monongahela North Section 1 along the Point State Park Plaza, Allegheny North Section 1 serving PNC Park and Allegheny Landing, as well as the Ohio North section 1: segments 12–15 next to Carnegie Science Center, and Rivers Casino. These locations are typically maintained to a high level of aesthetics and service, with significant ongoing financial support from local government, philanthropy, and private industry.

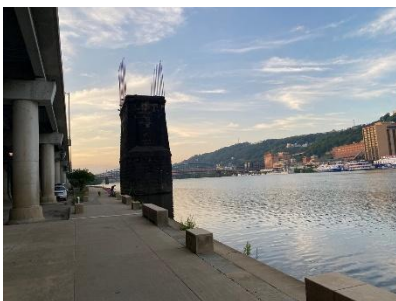
- Flood-Prone Areas: such as along the Monongahela Wharf Landing and the 10th Street Wharf Marina. These areas are often less visible to the public and do not necessarily enjoy the same level of financial support as more celebrated civic spaces. They are also under much more environmental pressure due to frequent flooding, sedimentation, and clean-up activities, which ultimately impacts the surface condition substantially. Concrete is a natural choice for these areas, due to the high durability to water forces and clean-up equipment traffic, when needed.

Of course, there are flood-prone areas along the Three Rivers Heritage Trails that are not surfaced with concrete - for instance, the Monongahela North Section 3: segments 1–3 from the Allegheny County Jail Parking Lot to the 10th Street Bridge. This area is not subject to flooding from the river, but does appear to be poorly drained with a relatively large drainage area, few stormwater catch basins, and positioned within a localized sump area. It is not surprising, given these conditions, that this trail segment was rated in poor condition, as part of this study. In this case, as well as flood prone areas, the use of concrete is recommended.
