BROWNSVILLE ROAD CORRIDOR

TRAFFIC SAFETY PLAN

Calhoun Ave to Maytide St.

Focus Group Meeting Date-05/23/2023

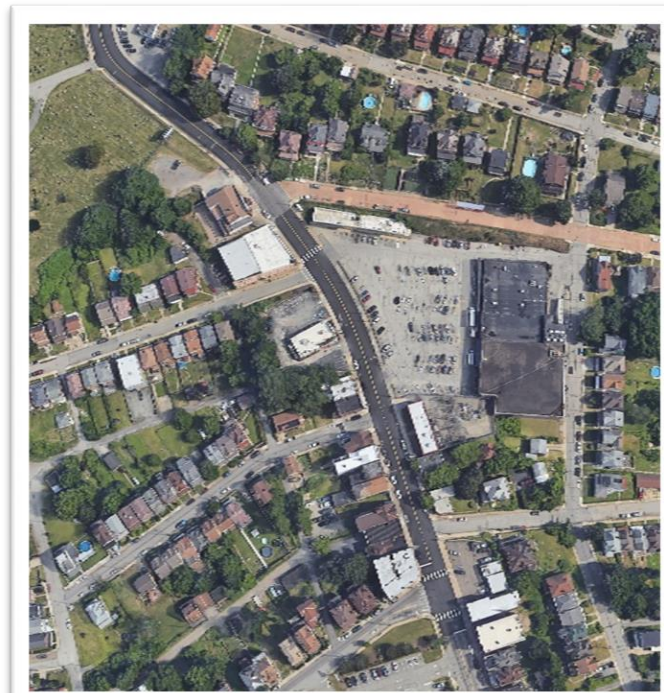
Wynoka St & Brownsville Rd “Y” Intersection

- High pedestrian generator segment.
 - High volume driveways.
 - Un-signalized pedestrian crossing location
 - Lighting improvements needed
- Wynoka St should be realigned from a “Y” to a “T” intersection.

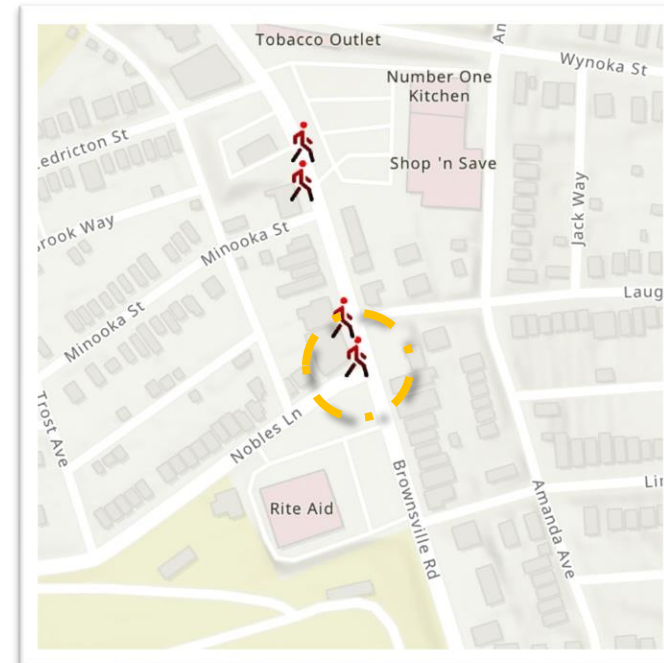
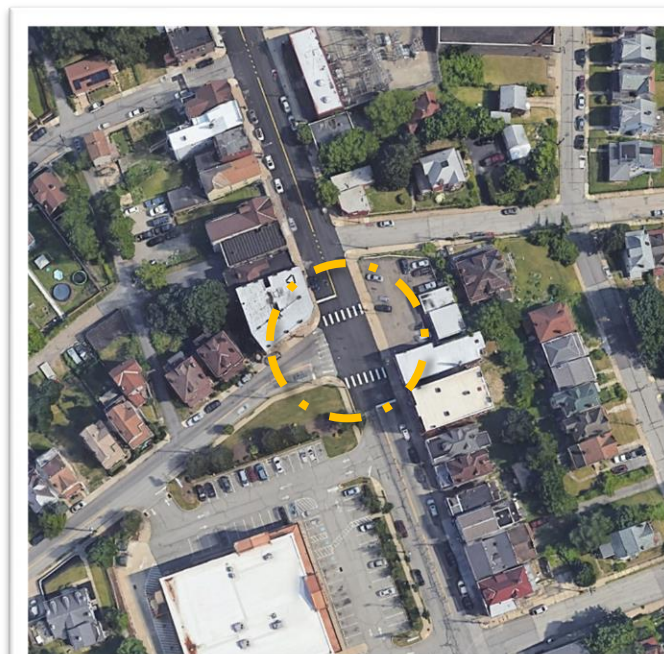
Nobles Ln & Brownsville Rd

- ADA ramp & sidewalk upgrades needed
- Pedestrian crossing improvements needed at the intersection

- Evaluate proper lane delineation & Left turn lane.
- Full signal replacement.

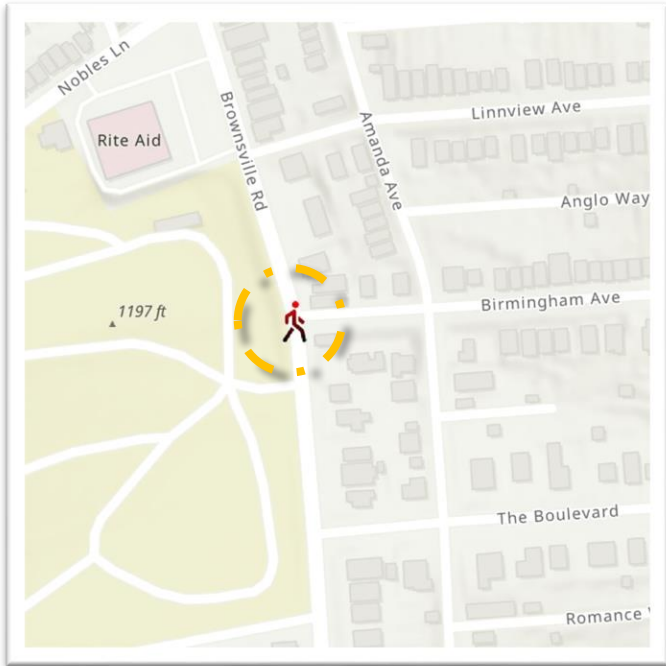
Birmingham Ave & Brownsville Rd

- Un-signalized pedestrian crossing needs improvement
- Lighting improvements needed

One side street lighting which is present along the corridor creates dark spots along intersections and driveways (seen above).

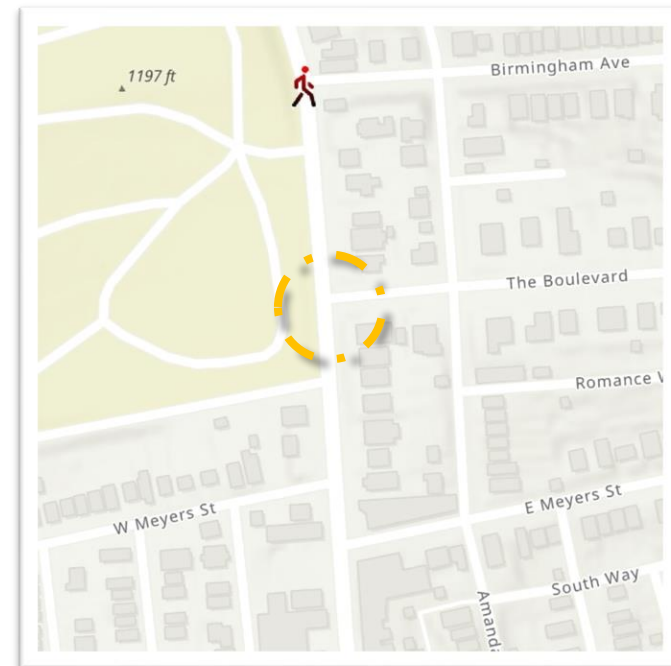
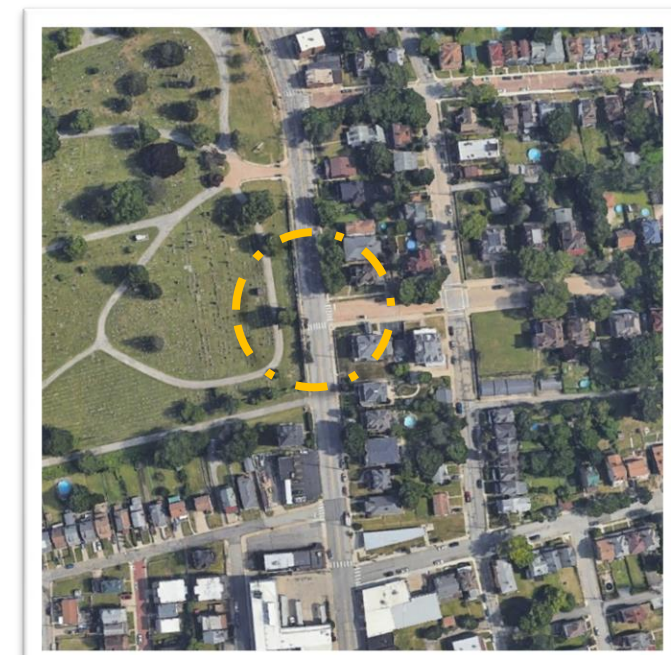
The Boulevard & Brownsville Rd

- Un-signalized pedestrian crossing
- High pedestrian generator Pittsburgh Roosevelt Pre-K 1

No Bus Shelters at this location.

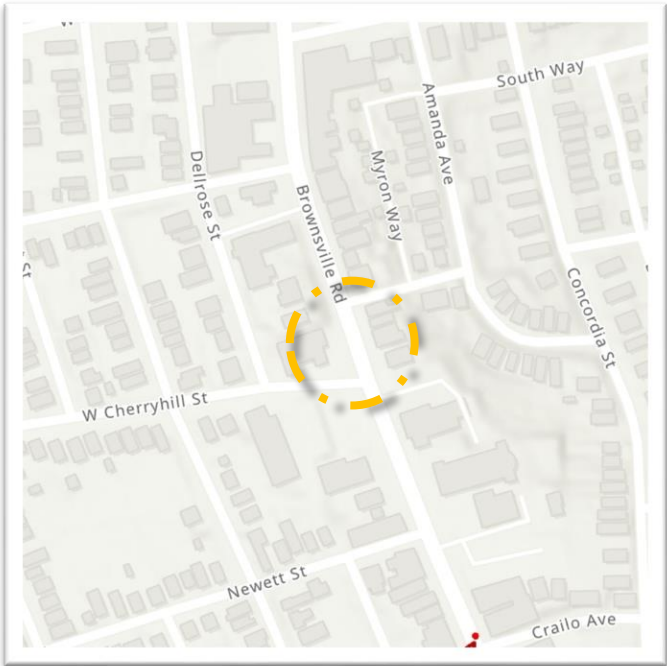
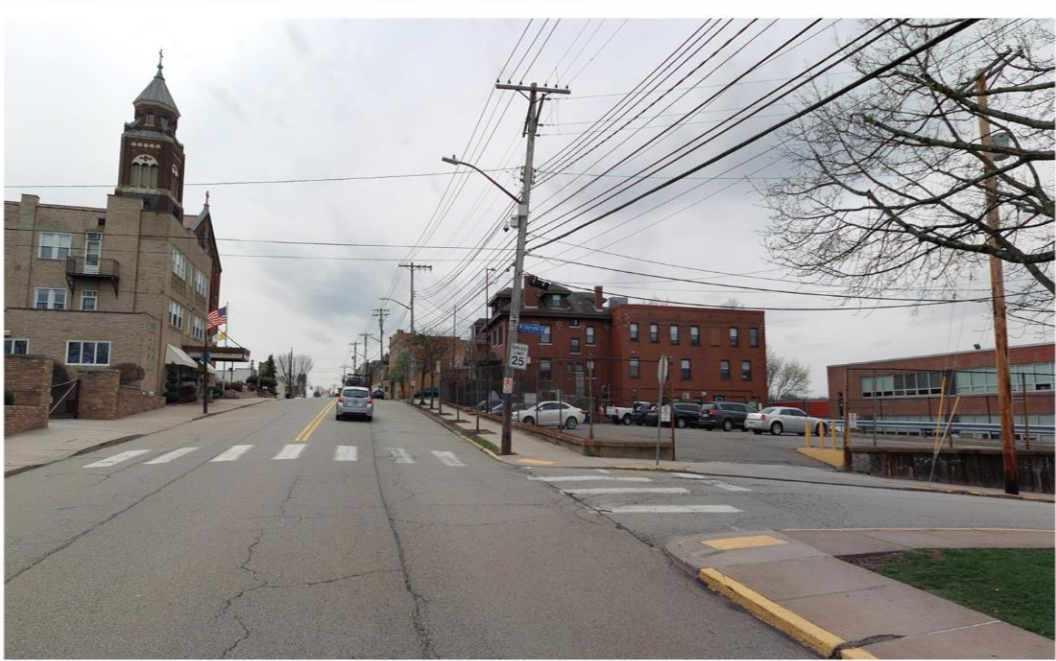
Cherryhill St & Brownsville Rd

- Un-signalized pedestrian crossing needs improvement
- High Pedestrian generator – Roosevelt 2-5.

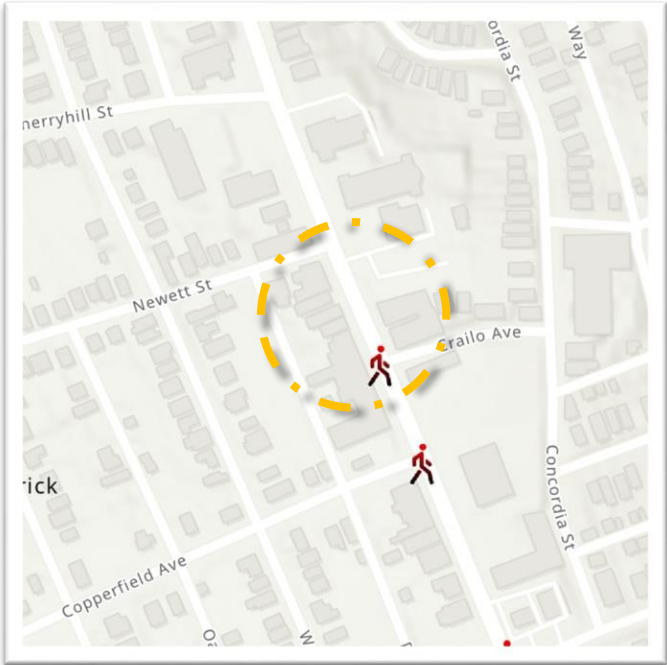
Newett St to Crailo Ave

- Newett St: Sightline improvement needed.
- Crailo Ave: Signal is outdated and requires full replacement to improve pedestrian accommodations.
- Sidewalk upgrades needed

Outdated ADA Curb Ramps at Crailo and Newitt (both)

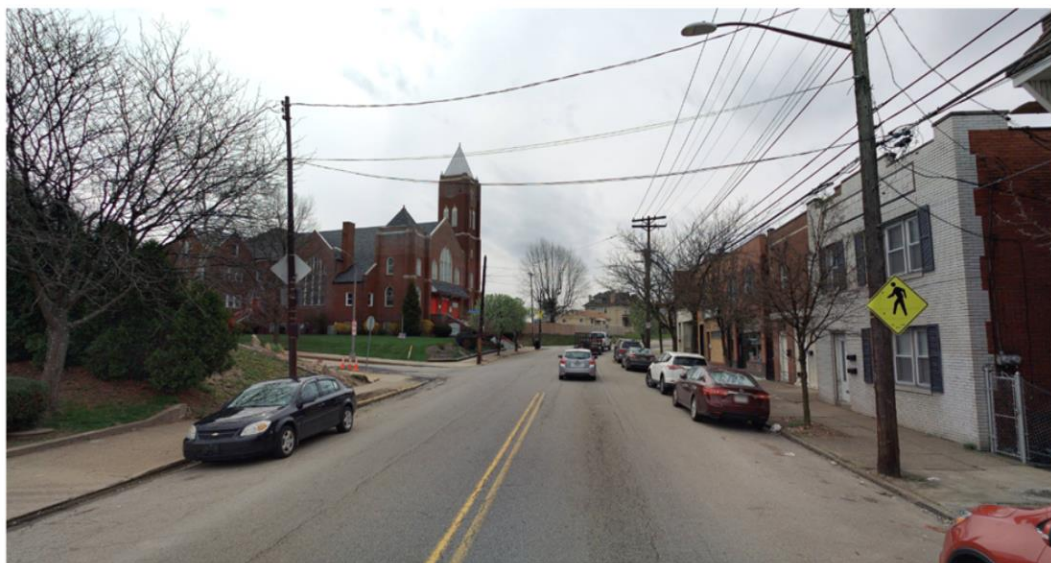
Hornaday & Brownsville Rd

- Speeding concern.
- Sidewalk upgrades needed.
- City is aware of the drainage issue and working on a separate Initiative. Not part of this project.

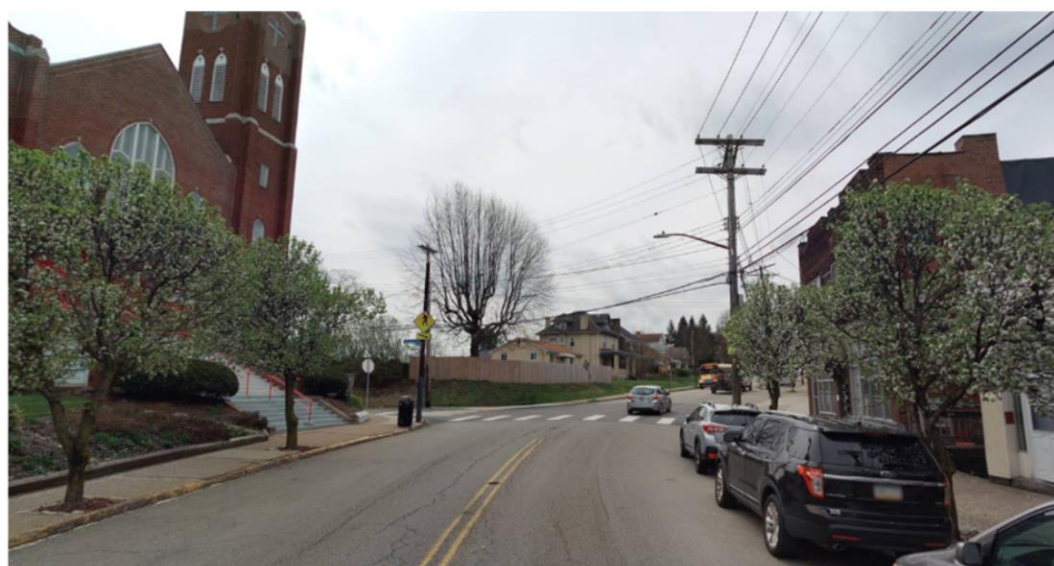
Madeline St & Brownsville Rd

- Un-signalized pedestrian crossing needs improvement.
- Sidewalk upgrades needed
- Pedestrian generator Zion Christian Church
- Parking near the crosswalk is prohibited and need further reinforcement.

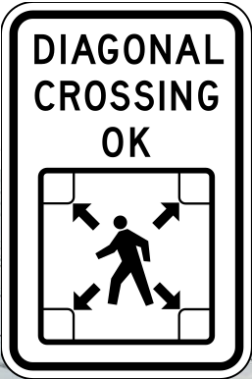
Parkfield St & Brownsville Rd

- High pedestrian generators: Carrick High School, shops and apts.
- Speeding issue around the curve.
- New signal in place with scramble phase. Signage needs to be added to indicate diagonal crossing .

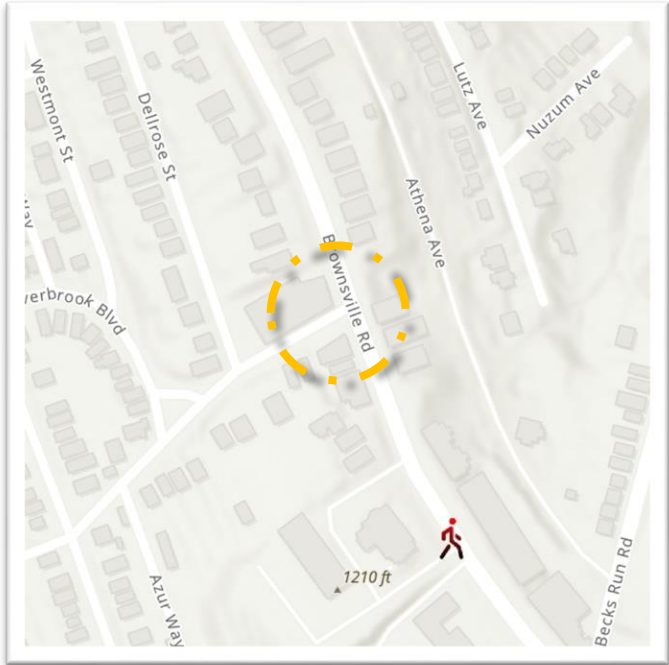
Overbrook Blvd & Brownsville Rd

- Un signalized pedestrian crossing needs improvement
- Sidewalk upgrades needed
- Evaluate left turn lane necessity
- Discourage parking near crosswalk.

Vehicles turning on to Brownsville Rd from Overbrook have limited sightline due to adjacent buildings.

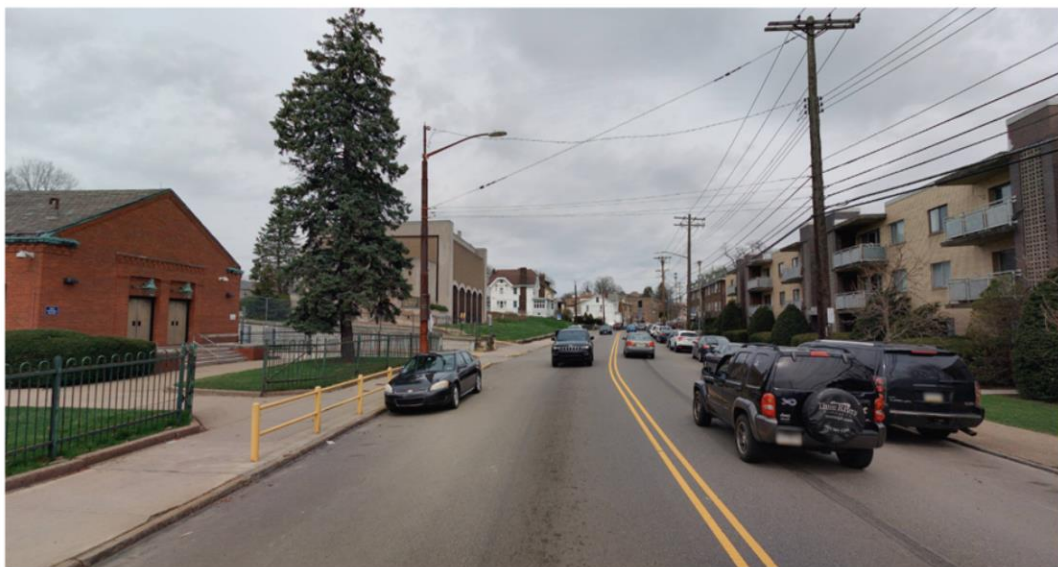
Ravella Ave to Becks Run Rd

- Multiple pedestrian generators: Concord Elementary School, St. Pius X Byzantine Catholic, Apartment buildings.
- Church bus stop connection and pedestrian crossing accommodation needed.

- **Mid-Block crossing location**
- Proper parking lane delineation, access management needed, and sight line improvements needed around church and school.

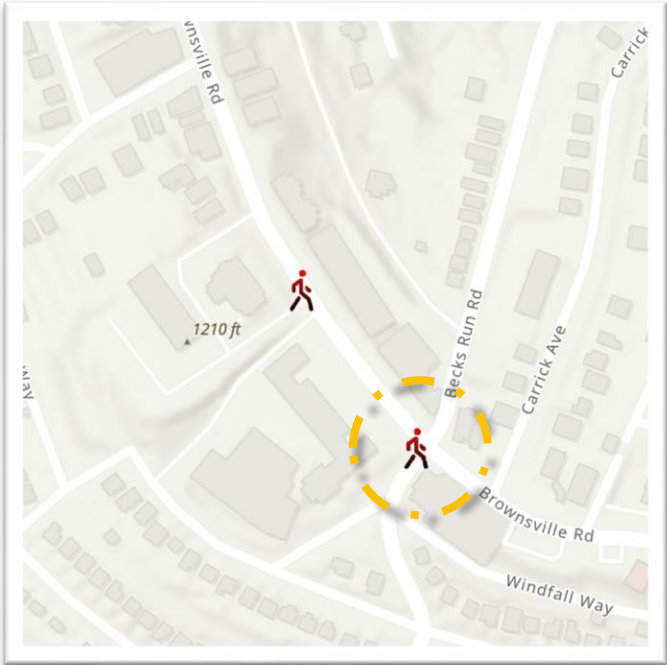
Biscayne Dr / Becks Run Rd

- Multiple pedestrian generators: Concord Elementary School, St. Pius X Byzantine Catholic, Apartment buildings.
- Signal upgrade needed.
- Lighting upgrades needed

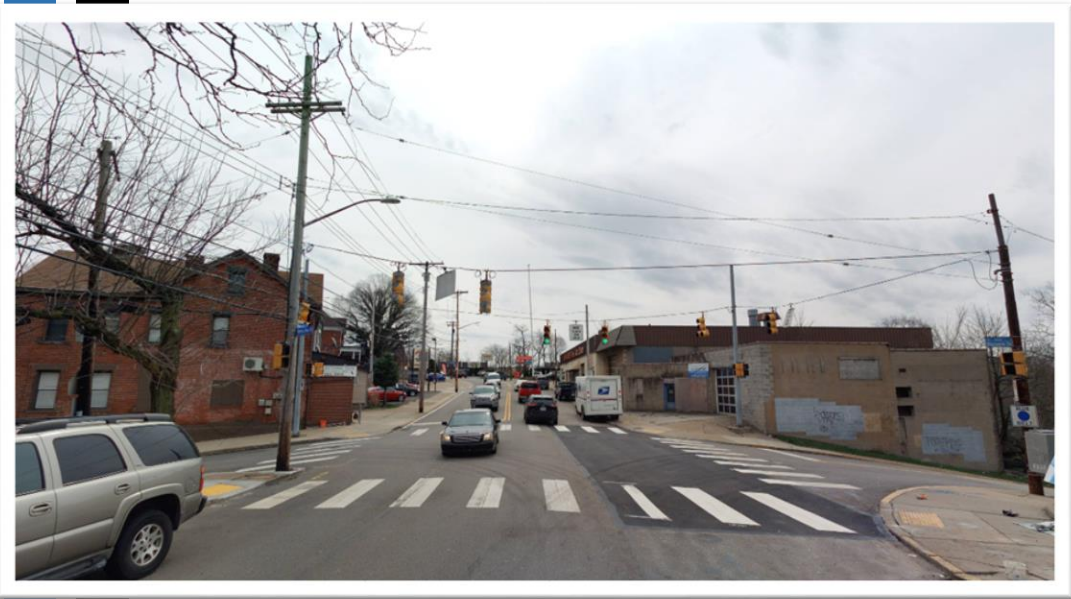
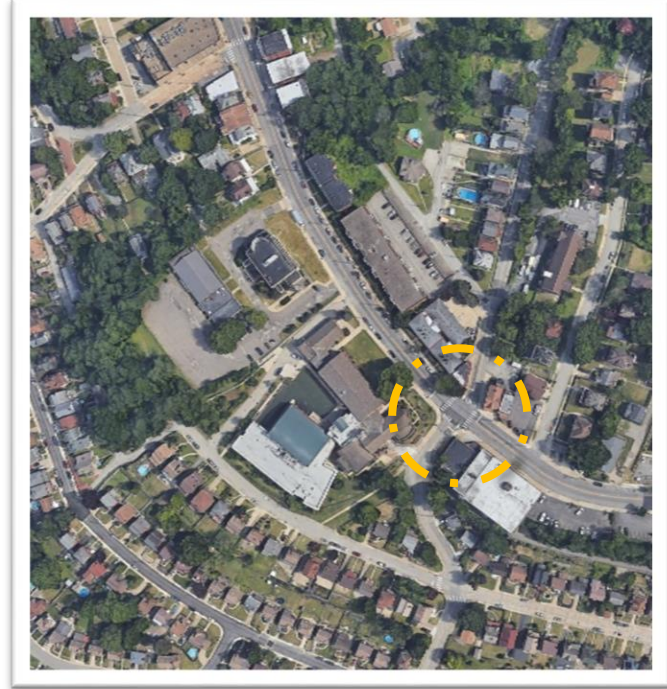
Clifton Blvd & Brownsville Rd

- Un-signalized pedestrian crossing location
- Lighting upgrades needed
- Sidewalk upgrades needed

Sidewalk on the south side of Brownsville Rd approaching Clifton Blvd is deteriorated and needs improvements.

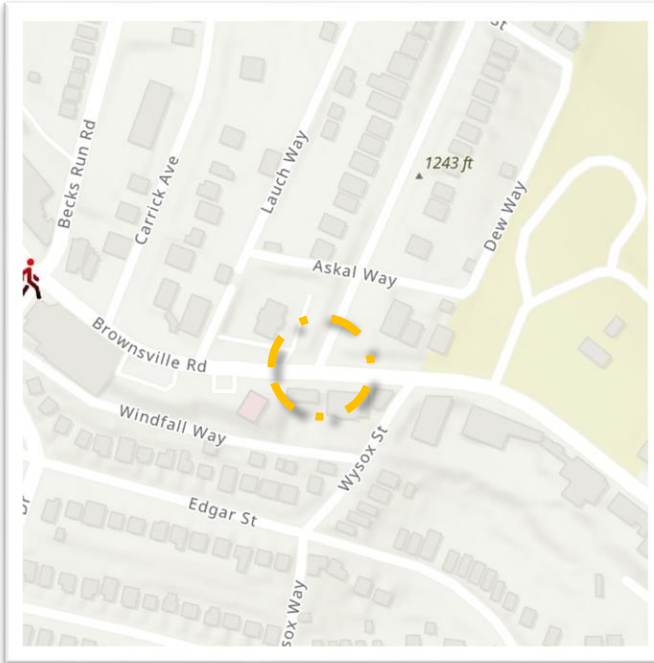
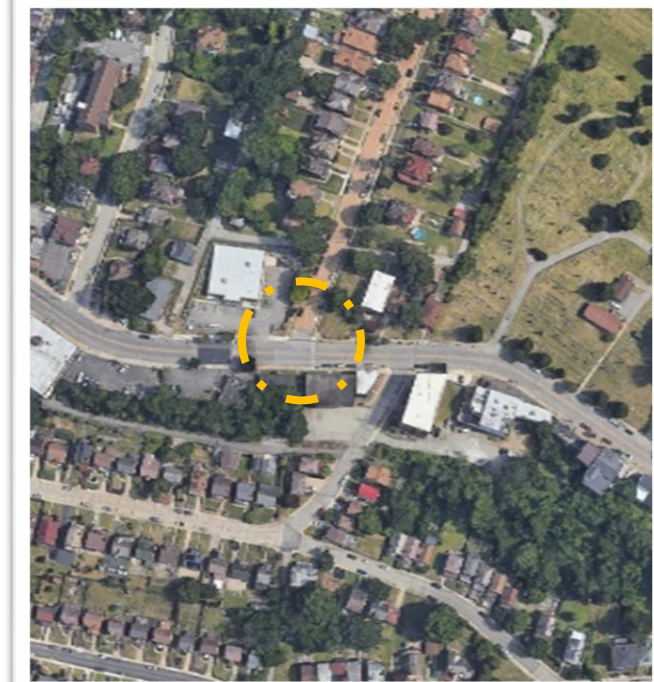
Wycox St & Brownsville Rd

- Speeding concerns.
- Sightline improvement needed.

Wycox and Brownsville is not an appropriate intersection for pedestrian crossings. Pedestrians should be encouraged to cross at Clifton.

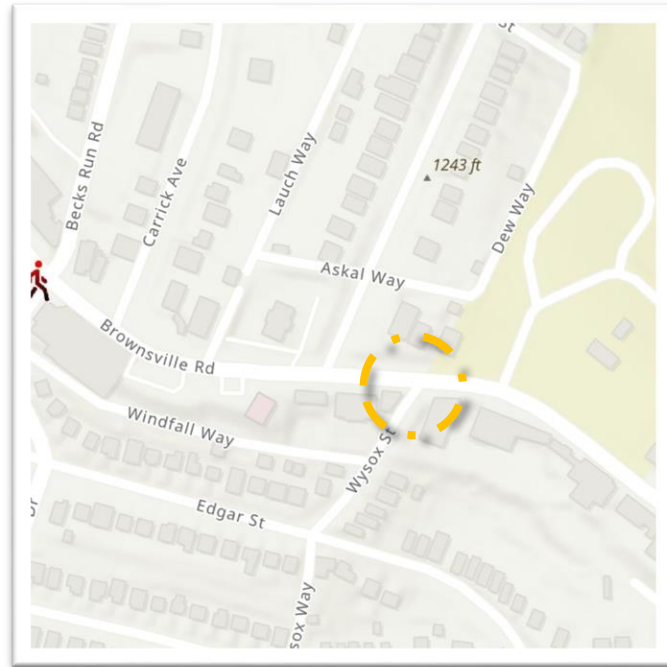
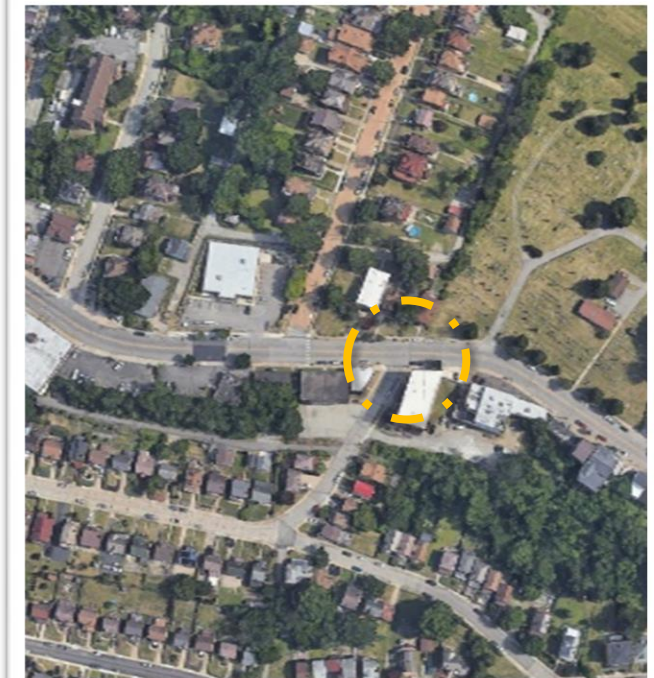
Churchview Ave & Brownsville Rd

- Sightline issues. Intersection should be realigned from “Y” to “T”
- Un signalized pedestrian crossing improvements needed.
- Crosswalk upgrades needed.
- Lighting upgrades needed.

- Sightline issues at Gas station due to parking
- Sidewalk upgrades needed
- Lighting upgrades needed
- Lane delineation improvements needed

The “Y” intersection creates sightline issues for vehicles turning on to Brownsville Rd.

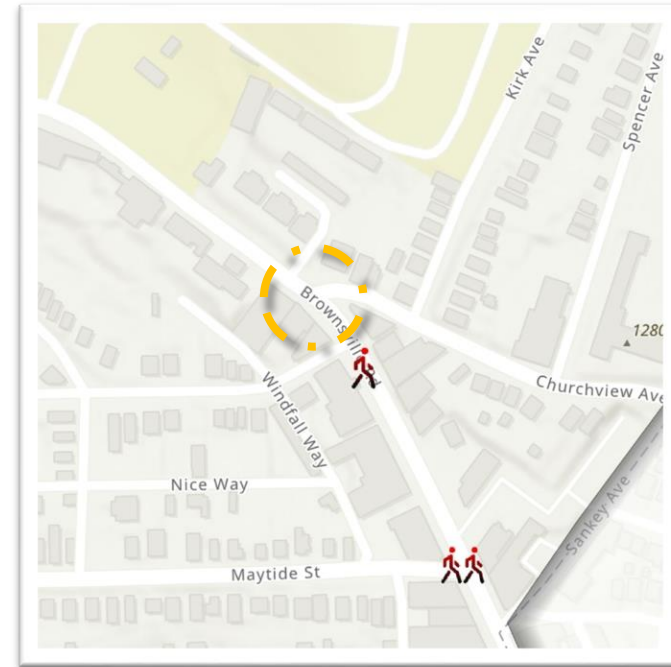
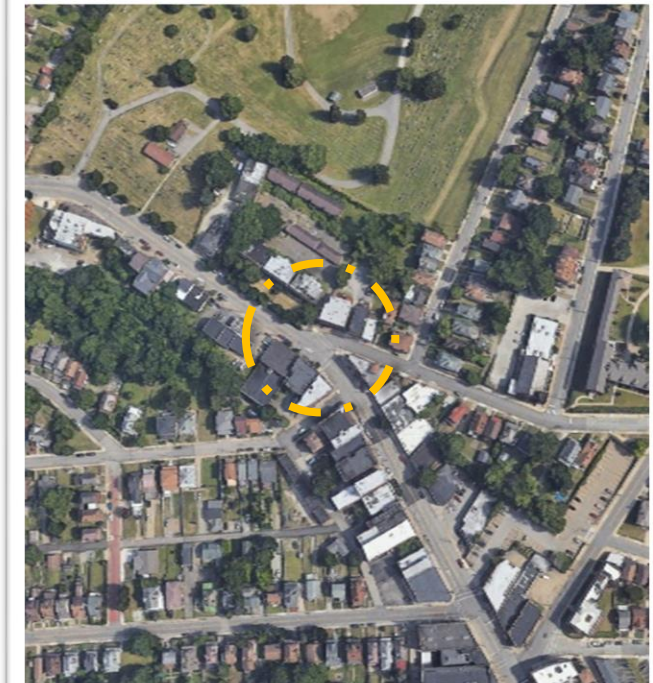
Belplain St & Brownsville Rd

- Sightline issues due to grade .
- Sidewalk upgrades needed
- Crossing should be discouraged at this intersection and directed to Chruchview Ave.

The grade of Belplain St creates a sightline issue for vehicles approaching Brownsville Rd.

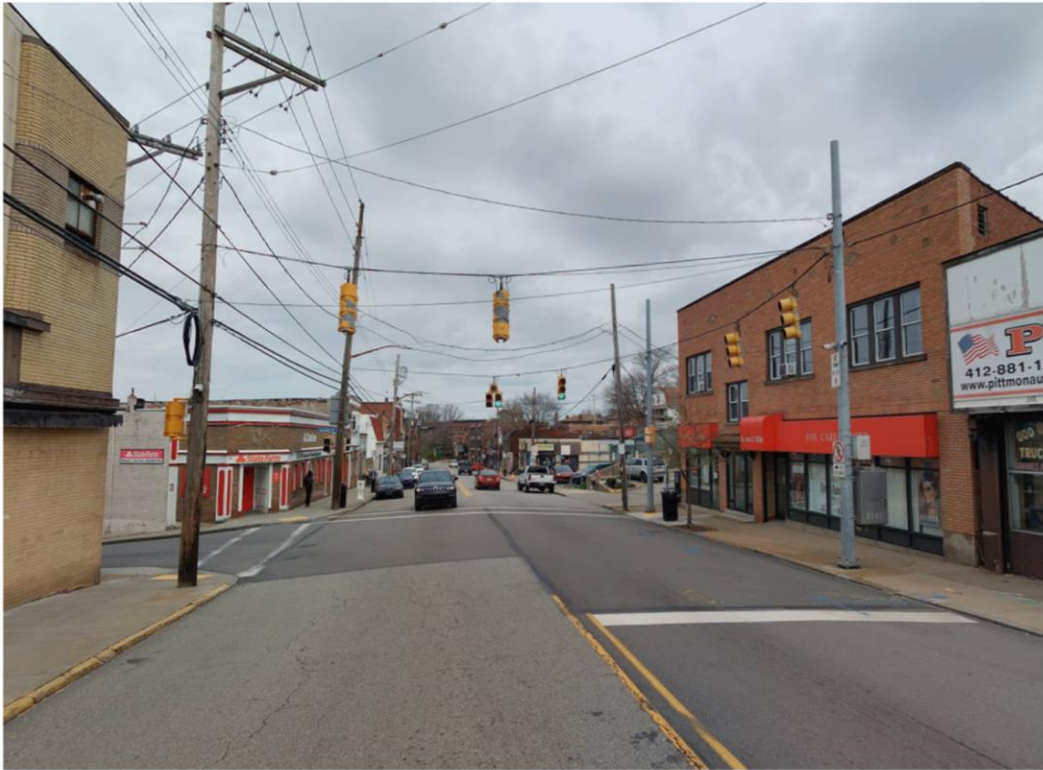
Maytide St & Brownsville Rd

- Pedestrian crossing amenities need upgrade.
- Need to evaluate if left turn lane is necessary
- Sidewalk upgrades needed
- Lighting upgrades needed
