DEPARTMENT OF PUBLIC WORKS

Demolition of the Cowley-Goettman Recreation Center

Community Meeting #2

April 10, 2019

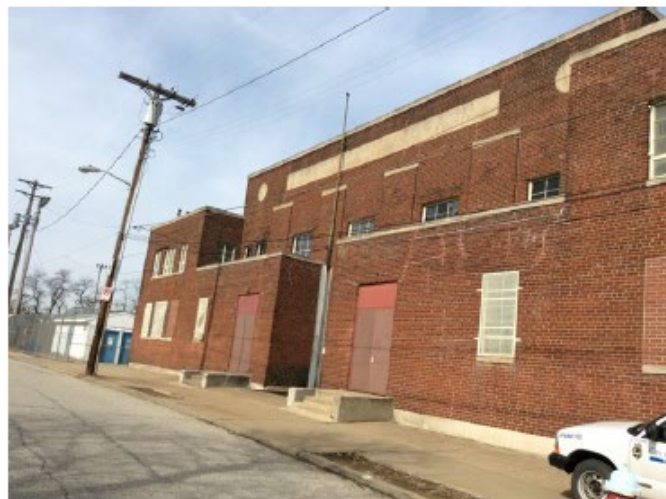
B034 - COWLEY RECREATION CENTER

General Physical Conditions - Poor Condition

The facility is unoccupied and has been poorly maintained for the last thirteen years.

It is severely deteriorated and in a significant state of disrepair. The gym floor has been ruined due to water infiltration. All Vinyl Composition Tile (VCT) flooring has become unglued and all painted surfaces have peeled, due to exposure to an unconditioned space. The windows are original and need to be replaced. All of the Acoustical Ceiling Tiles (ACT) need to be replaced as well as all the doors. An asbestos and lead-based paint (LBP) testing is required.

The existing MEP systems are original to the building and need to be replaced. All of this work would have to be done immediately in order for the facility to be occupied.

The boiler was installed in the late 1930s. It has not run or has not been serviced in 13 years. It has reached the end of its expected life cycle and is in a state of significant disrepair. The unit needs to be replaced/rebuilt immediately.

Although no significant deficiencies were observed except for the membrane on the parapet, the roof system warranty expired in 2007. As the facility is vacant, the roof hasn't been inspected and is at the end of its expected life cycle and will need to be replaced prior to re-occupying the building.
